Appropriate Assessment Screening – Note TO289/RM01

Project:	5162160_TO 289 NW Bridges		
Subject:	Reactive Maintenance - AA Screening No.4		
Author:	Niamh Sweeney, Atkins, Senior Ecologist Paul O'Donoghue, Atkins, Principal Ecologist	Atkins No.:	Appropriate Assessment Screening – Note TO289/RM04. Revision 0
Date of Query:	09/01/2019	Date Issued:	9/01/2019
Distribution:	Christian Nea Vincent O'Malley [REDACTED]	Representing:	TII TII Atkins Atkins

Bridge	Coolloughra Bridge, Scregg, Co. Mayo
Structure ID	MO-N60-015.00
County	Mayo
Location	<p>Coolloughra Bridge is situated on the N60, approximately 3.3km east of Ballyhaunis town and 15km west of Castlerea, Co. Mayo.</p> <p>Cooloughra Bridge spans the Moneymore stream, which is a tributary of the River Dalgan. The River Dalgan flows for a considerable distance (approximately 30km) until it joins the Clare River. The Clare River ultimately discharges to Lough Corrib.</p>

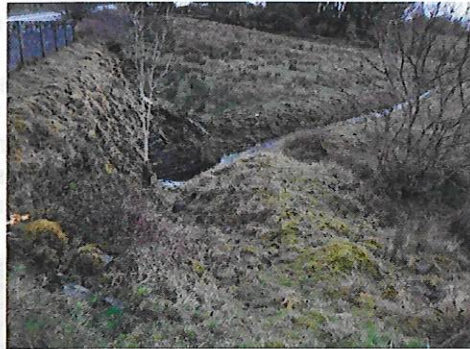
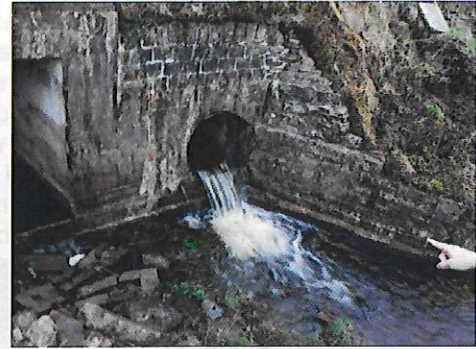
Plate 1. Downstream of Coolloughra Bridge, showing box culvert and concrete pipe.

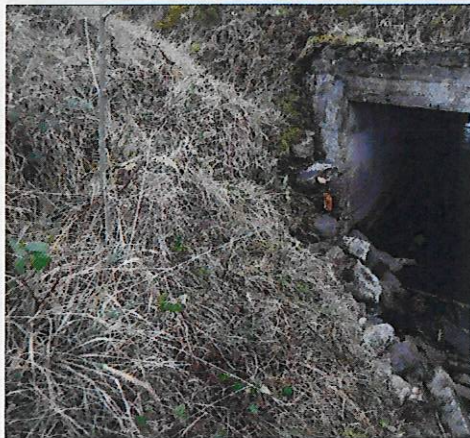
Plate 2. Wall collapse on the downstream side of Coolloughra Bridge.

1. Regrading of bund adjacent to bridge which caused wall collapse.
2. Removal of 5m² of debris from the watercourse (collapsed wingwall).
3. Additional 5m² of wall rebuild including scour protection on north side (there is an area of scour under the debris that needs to be removed).
4. Additional 2m² of rock scour protection on south side.
5. 2m² of concrete repairs to concrete pipe as water is leaking from several locations.

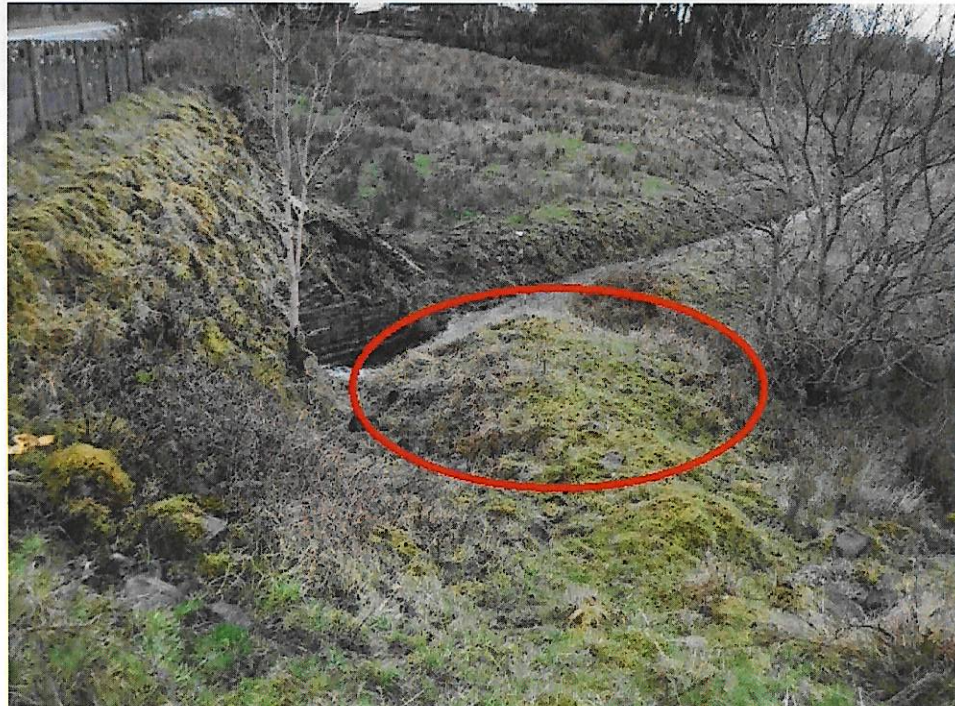
The area of the bund adjacent to the bridge requiring regrading (Item 1) is shown in Plate 4 below. The area requiring regrading is circled in red and will be regraded to a 45 degree slope away from the water. This is necessary to allow the wingwall to be rebuilt (Item 3). The regrading works will be carried out using a small excavator and works will be carried out from the riverbank. No machinery access to the channel will be required. The material will be disposed of as per the waste management requirements of the bridge maintenance contract. The removed material will be removed from site.

Plate 4. Mound of material to be regraded to a 45 degree slope (circled in red).

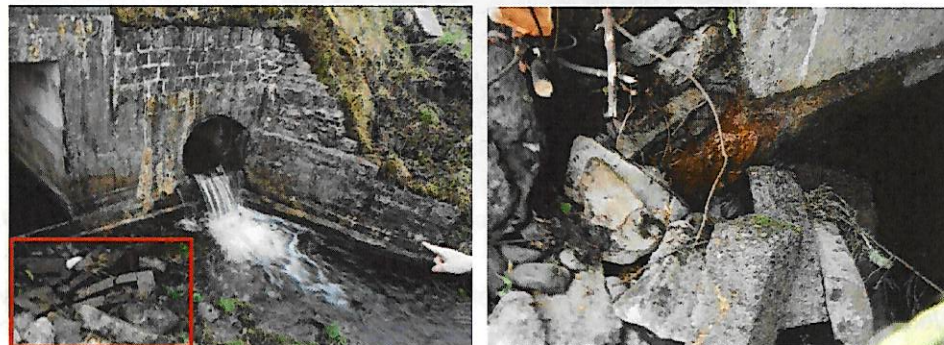
Plate 5. Debris within the channel (collapsed wingwall)
