Re. Bangor Erris Bridge (MO-N59-023.00) [Reactive Maintenance]

Bangor Erris Bridge is on the N59 Regional road south of Bangor, Co. Mayo; as shown below circled in red (Source: NBDC webviewer). The bridge spans a small stream which flows westwards to Tullaghan Bay. The north east curved section of parapet wall has been severely damaged following vehicular impact.

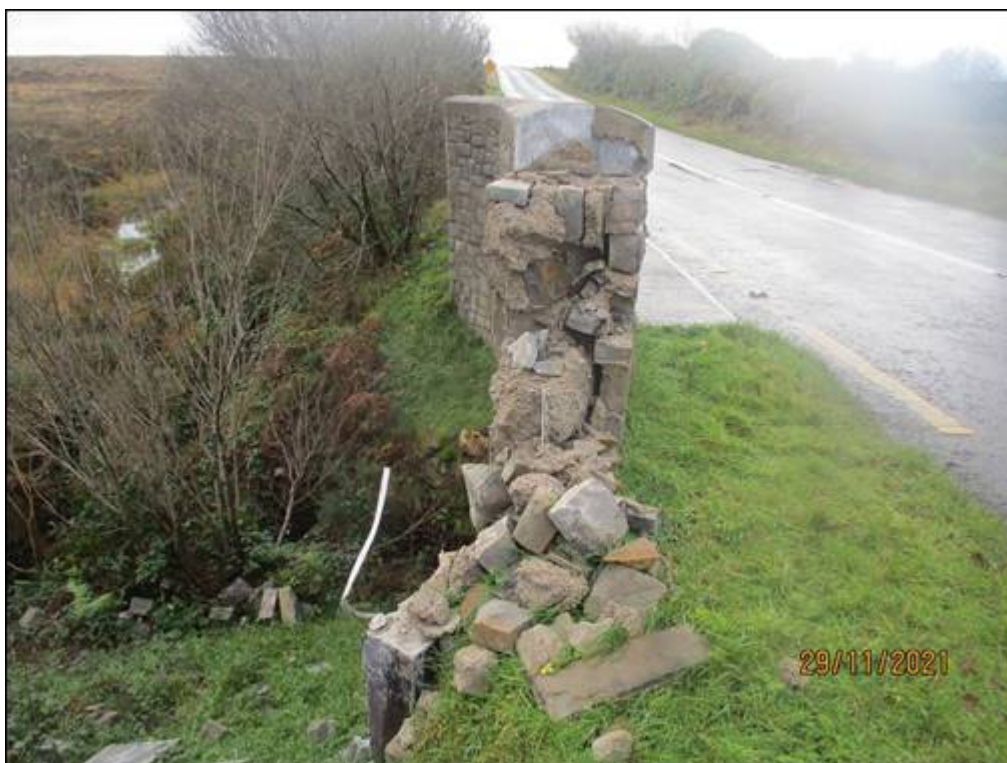
The north east curved section of parapet wall is 500mm thick and comprises an unreinforced stone masonry wall faced both sides in up to 140mm thick cut stone masonry set in a random joint pattern. The infill concrete to the wall appears to be a weak concrete. The parapet wall is capped with 500mm thick stone masonry profiled copings x 250mm high at top. The finish to the copings appears to be a lightly textured bush hammered finish. The height of the damaged parapet wall including copings is 1550mm and extends 150mm below the level of the roadside grass verge. The parapet wall extends from the top of the wingwall constructed below. The wingwall also measures 500mm thick and comprises a 225mm thick cast in-situ concrete core with up to 140mm facing stonework (including buried face) set in a random joint pattern and fixed using Ancon wall ties set into channels cast into the concrete wall. The total inside length of the curved parapet/ wingwall extends 2000mm to a joint that separates the curved section of the wall from the straight section of wall that extends over the bridge.

The curved parapet wall is partly demolished over a length of 1300mm including 4 No. copings stones (predrilled for dowelling) which are lying both on the embankment and the watercourse below some of which appear to be intact. The remainder of the curved section of parapet wall is largely in disrepair with loose/displaced masonry and displaced copings and random joint separation cracking noted. Some joint separation cracking was also observed above/below the top course of masonry below the copings extending some 700mm past the separation joint into the straight section of wall. Loose sections of mortar were noted between 4 No. copings extending over a length of 1200mm past the separation joint. An area of masonry facings measuring 0.5m² has been dislodged from the internal face of the wingwall below exposing the concrete core and with protruding ends of the cast in channels partially damaged. The masonry wall debris largely lies on the adjoining river embankment with some masonry debris lying in the watercourse below. The debris appears to have flattened some trees growing at the foot of the embankment and which are lying in the watercourse. Crash debris was also observed lying in the watercourse below notably plastic and litter. Some minor localised crash debris was noted lying on the embankment.

Plate 1 Damage to Bridge parapet.

The damaged parapet is above the riverbank adjoining the river; not directly over the stream itself. It is adjoined by grassland on both the road and river side (see Plate 1). There are no bog, heath or mire habitats at the proposed works area. None of the lake habitats for which the SAC has been designated are located at the bridge (i.e. habitat 3110 or 3160; refer to Map 3 of NPWS, 2017). Debris which has fallen into the stream would be removed by hand.

- Remove 12m² of masonry debris from embankment. Remove 3m² of debris from watercourse below. Remove 5m² of vegetation from watercourse.
- Rebuild north east damaged curved parapet wall to full height and reinstate 6 No. profiled stone masonry copings (pre-drilled for dowelling), all to match existing.
- Rebuild damaged top course of wall to section of straight section of wall (extending past separation joint) and reinstate 4No. profiled copings (pre-drilled for dowelling) on top where mortar between units is loose, all to match existing.
- Reinstall separation joint sealant to repaired sections of wall.
- Reinstall masonry facings fixed to area of exposed concrete core to wingwall.
- Reinstall Structure ID.

The damaged wall is to be deconstructed to stable material, and then fully reconstructed using hand tools to tie in with the existing wall utilising the existing non-defective stone masonry facings salvaged from the embankment and watercourse, or if not possible, new locally sourced stone masonry to match existing wall, and lime mortars. The re-construction of the parapet wall is to match existing construction. The mortar for stone masonry facings will be mixed away from the structure to prevent contamination of the watercourse. All damaged masonry sections not suitable for re-use and other debris resulting from the damage to be disposed off-site. Measures should also be implemented to prevent materials from entering the watercourse during the works. Precautionary silt fencing to control and prevent any pollution of the watercourse should be erected at the edge of the works to intercept any runoff that might arise from the construction works. However, any such material would flow away from Owenduff/Nepin Complex SAC / SPA and not into it.
