Report on Advance Archaeological Testing of the proposed Metro West Depot, Merryfalls, Ballymun, Co. Dublin.

Project code: RPSM09

Client: Railway Procurement Agency

Licence No: 09E0274

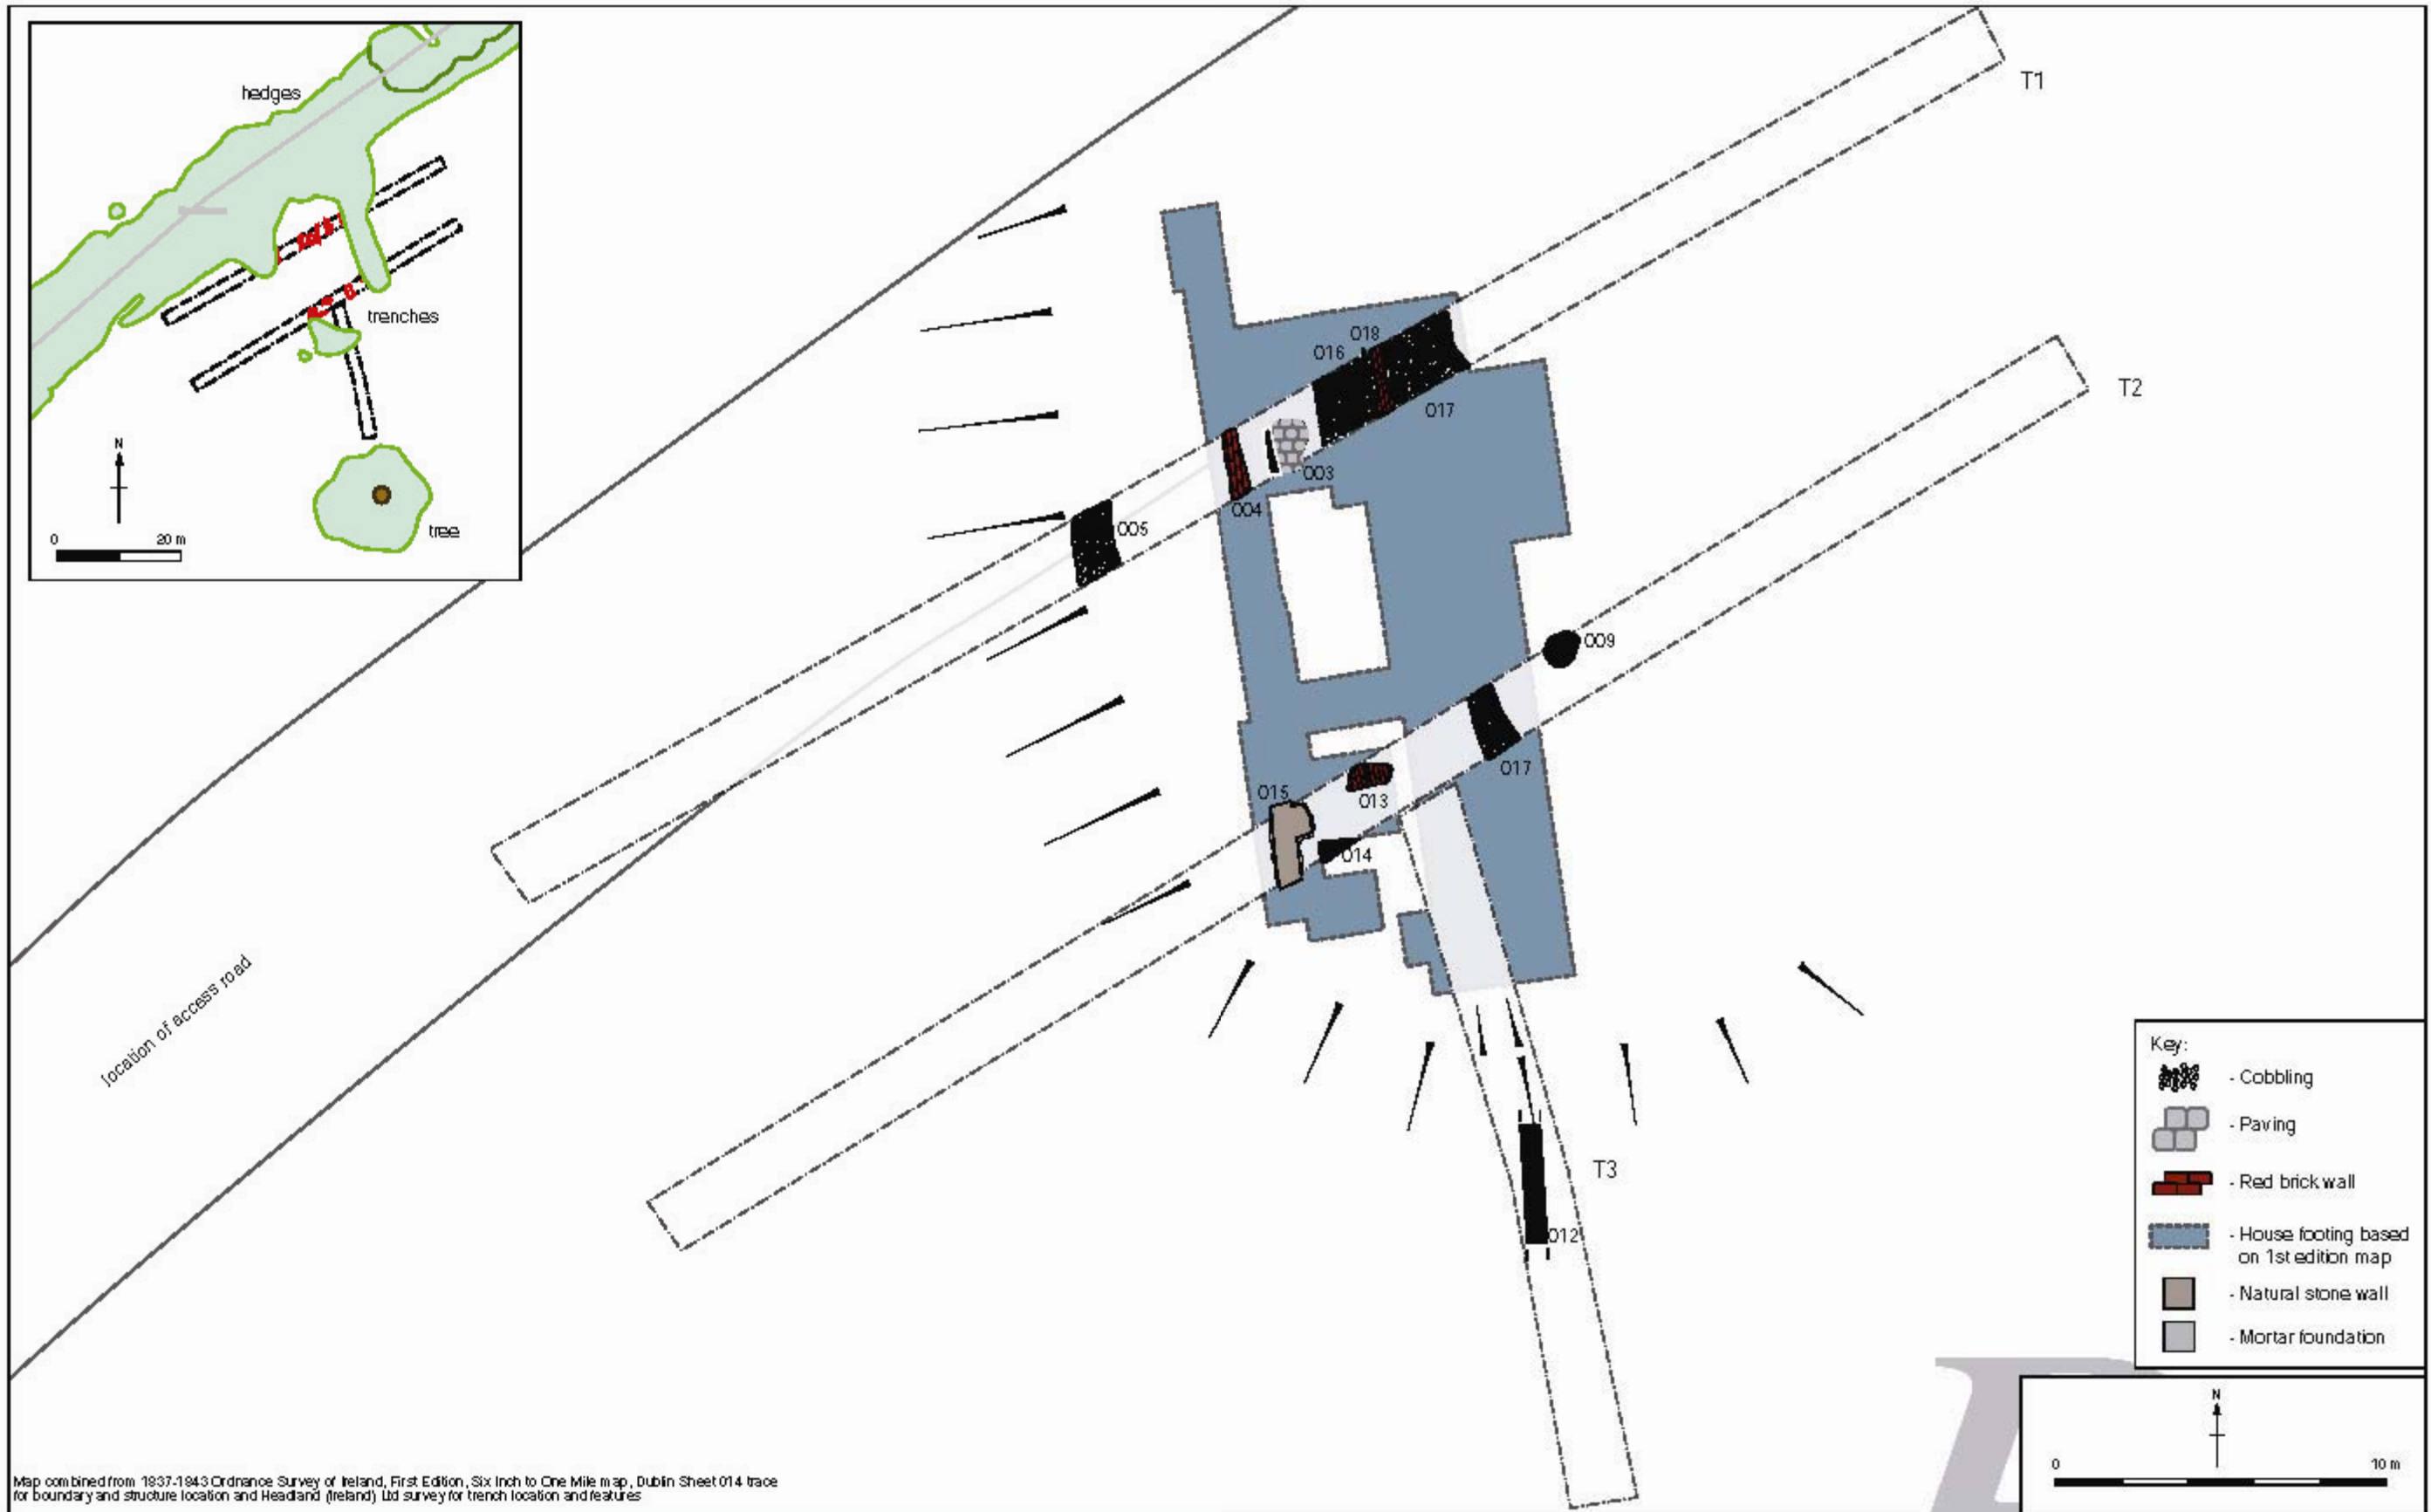
The limits of the structure, from the evidence visible in this trench, suggests a 13.2 m in width building with simple red brick walls, interior paved surfaces and cobbled walkways on the north and east aspects of the building and an overall north/south orientation, as depicted on the cartographic illustration.

The limits of the structure within this trench measures 9.2 metres and corresponds to the southern aspect of the structure, with a possible entranceway or small enclosed courtyard to the south.

Figure 2 - Metro West, Merryfalls Depot Option, Co. Dublin: 09E0274, Results of testing program overlaying 1st edition Ordnance Survey map.

The structure recorded in this investigation will be directly impacted by the proposed scheme. It is recommended that avoidance through re-design of proposed works be implemented. Should this prove non-viable, the design process should take in to consideration a recording strategy of the structure prior to any further work being carried out. This recording will entail exposing the full extent of the structure, with the aim of producing a scaled plan drawing of the structure and its environs. This will require a mechanical excavator, a team of two to three archaeologists and an archaeological surveyor. The recording should take two to three days to complete. The structure can be preserved under a geotextile protective membrane or excavated pursuant of a licence being

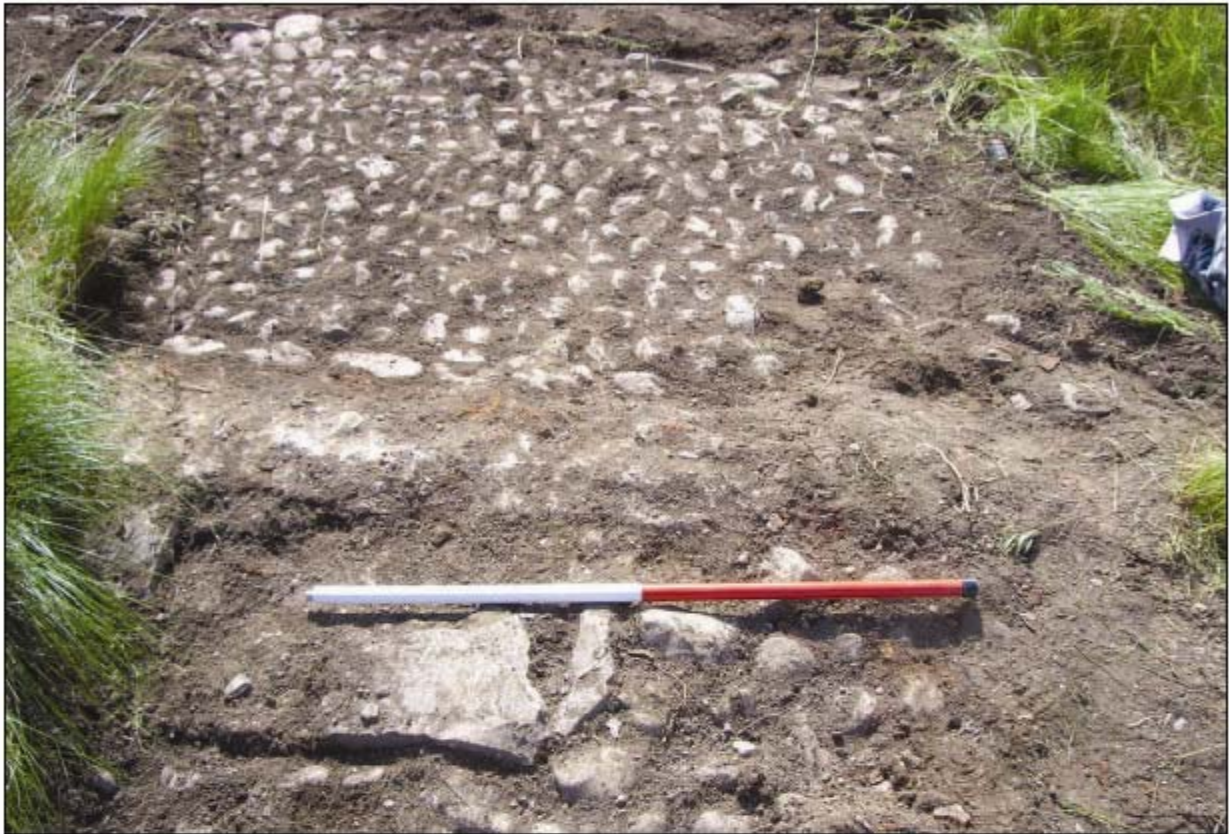
A cobbled surface (016, plate 1) lay approximately 0.6 m to the west of the paved surface (003). This surface was well constructed with larger kerb cobble stones to the west. The surface (016) ran in a north/south orientation and was 1.7 m in length, and 1.9 m available width. The eastern side of the surface was delineated by a north/south oriented double bond red brick wall (018, plate 1). This wall (018) measured 0.35 m in width, which in turn delineated the western edge of another cobbled surface

(017, plate 1). This surface (017) was well constructed with large kerb stones at the eastern edge, approximately 2 m in length and 1.9 m in available width.

This surface (017) corresponds to the eastern limit of the structure. This surface was also found in Trench 2.

Plate 1 - Trench 1, northern side of structure showing cobbled pathways (016, 017) and red brick wall (018), facing west.

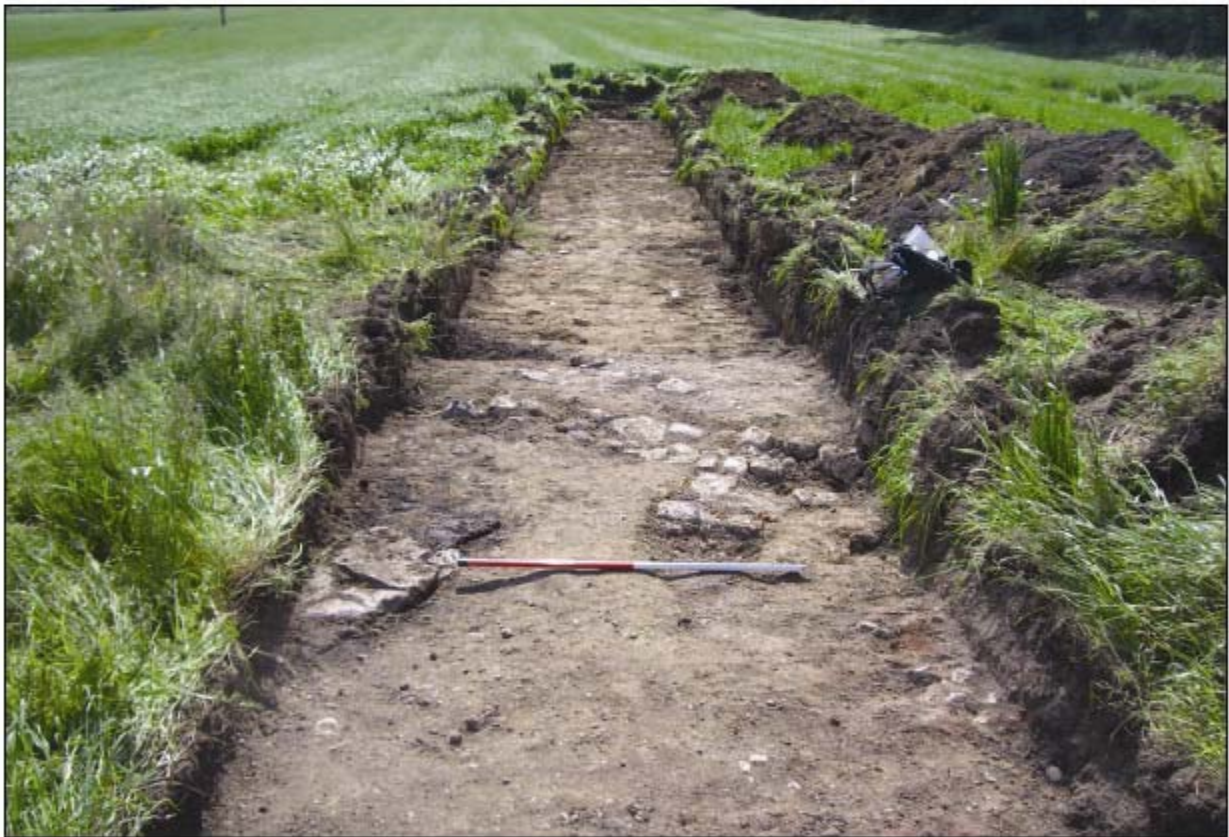
Approximately 0.60 m to the east of the wall foundation (015) lay a distinctly separate wall foundation (014, plate 2), in an east/west orientation and terminating approximately 0.65 m from the southern edge of the trench. The wall foundation was 0.45 m in width and comprised roughly cut masonry blocks and slabs. On the opposite side of the trench to the wall foundation (014) lay a red brick pillar setting (013, plate 3), roughly rectangular in shape with a central gap for a pillar or upright stanchion. The setting measured approximately 1.0 m east/west, 0.6 m north/south. The central gap measure 0.2 m by 0.3 m.

Plate 2 - Trench 2, southern side of structure showing wall foundations (014, 015), facing west.

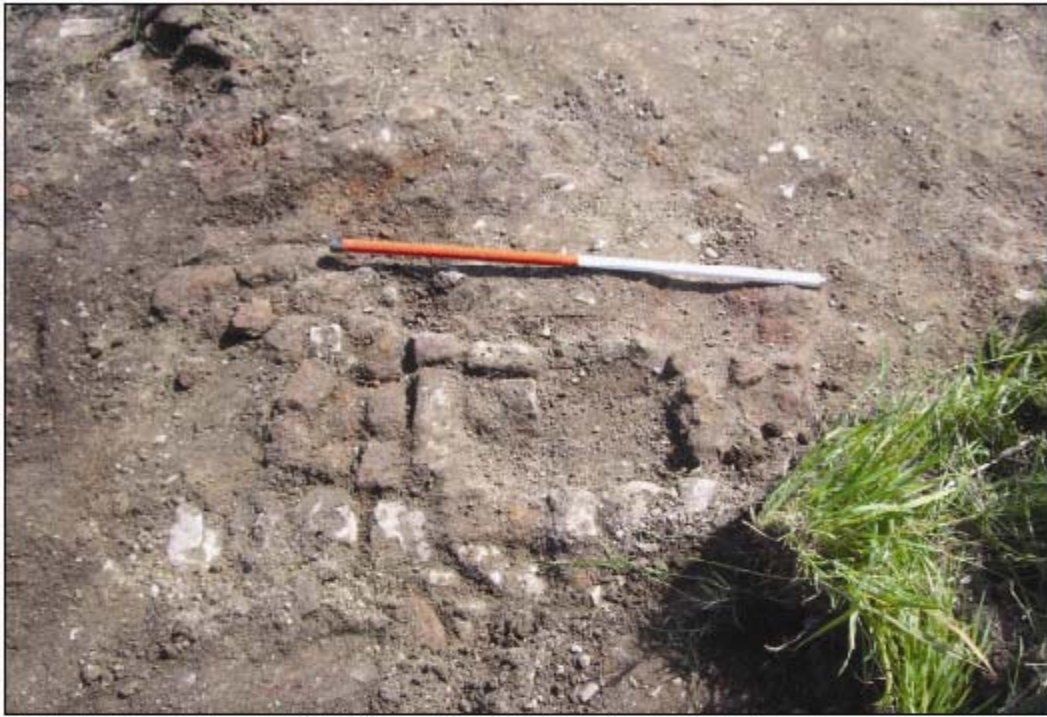
| Context no | Trench | Length | Width | Depth | Description |
|---|---|---|---|---|---|
| 013 | 2 | 1.0 | 0.6 | N/A | Rectangular red brick pillar setting, east/west oriented. |

Plate 3 - Trench 2, red brick pillar setting (013), facing northeast.

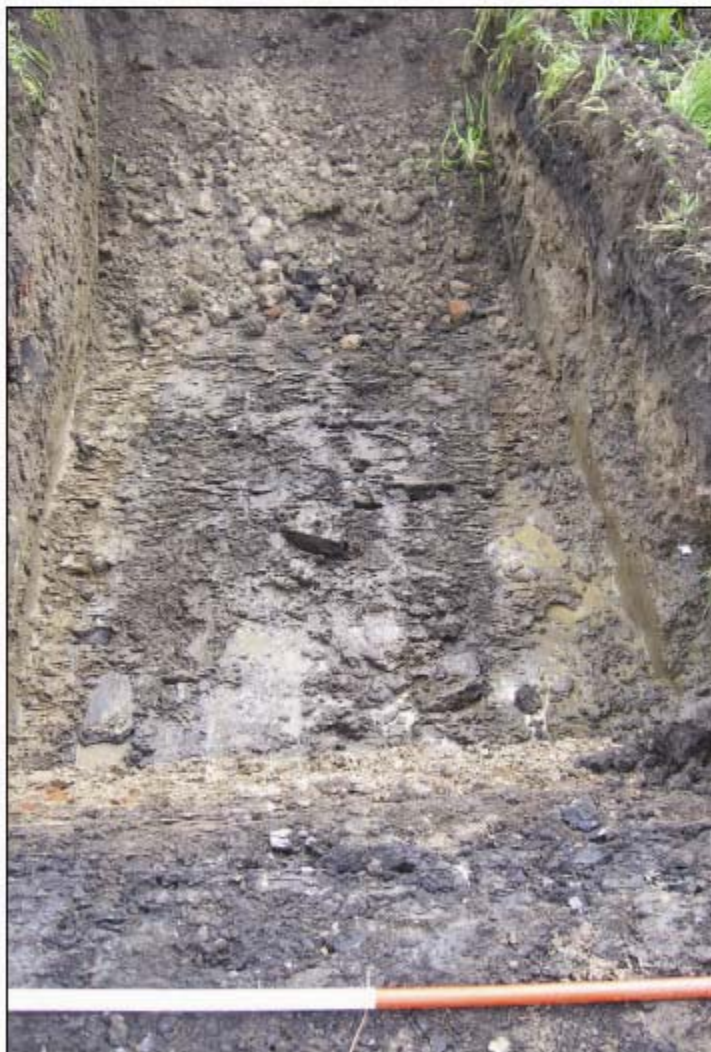
A large deposit (010) of grey mortar and building refuse was deliberately dumped in this area to level the southern aspect of the structures supporting artificial platform. It was encountered approximately one metre to the south of the structural remains in trench 2. The deposit was approximately 0.95 m in depth in the section face of the trench. A north/south running linear feature (012, plate 4) was exposed underneath the deposit (010), at a depth of 1.10-1.20 m below topsoil level, extending towards the sunken depression to the south. At this level, the water table was exposed and filled the trench rapidly. It is possible the linear feature may be associated with drainage or water supply for the structure. The linear feature (012) measured 1.2 m in width and approximately 4 metres of the feature was exposed. Due to the depth of the trench and the water table, no investigation could be carried out on this feature. No other features or deposits were exposed in this trench.

| Context no | Trench | Length | Width | Depth | Description |
|---|---|---|---|---|---|
| 011 | 3 | 4.0 (available) | 1.2 | N/A not investigated | Fill of north/south running possible drain (012). Under (010). Waterlogged. Not investigated due to depth and water inundation. |

Plate 4 - Trench 3, linear drain (012) under deposit (010), facing south.
