Archaeological monitoring of Metro North Utility Slit Trenching at St. Stephens Green, Dublin.

Ministerial Consent Registration Number: E3963

Project code: RPUT09

Date: October 2009

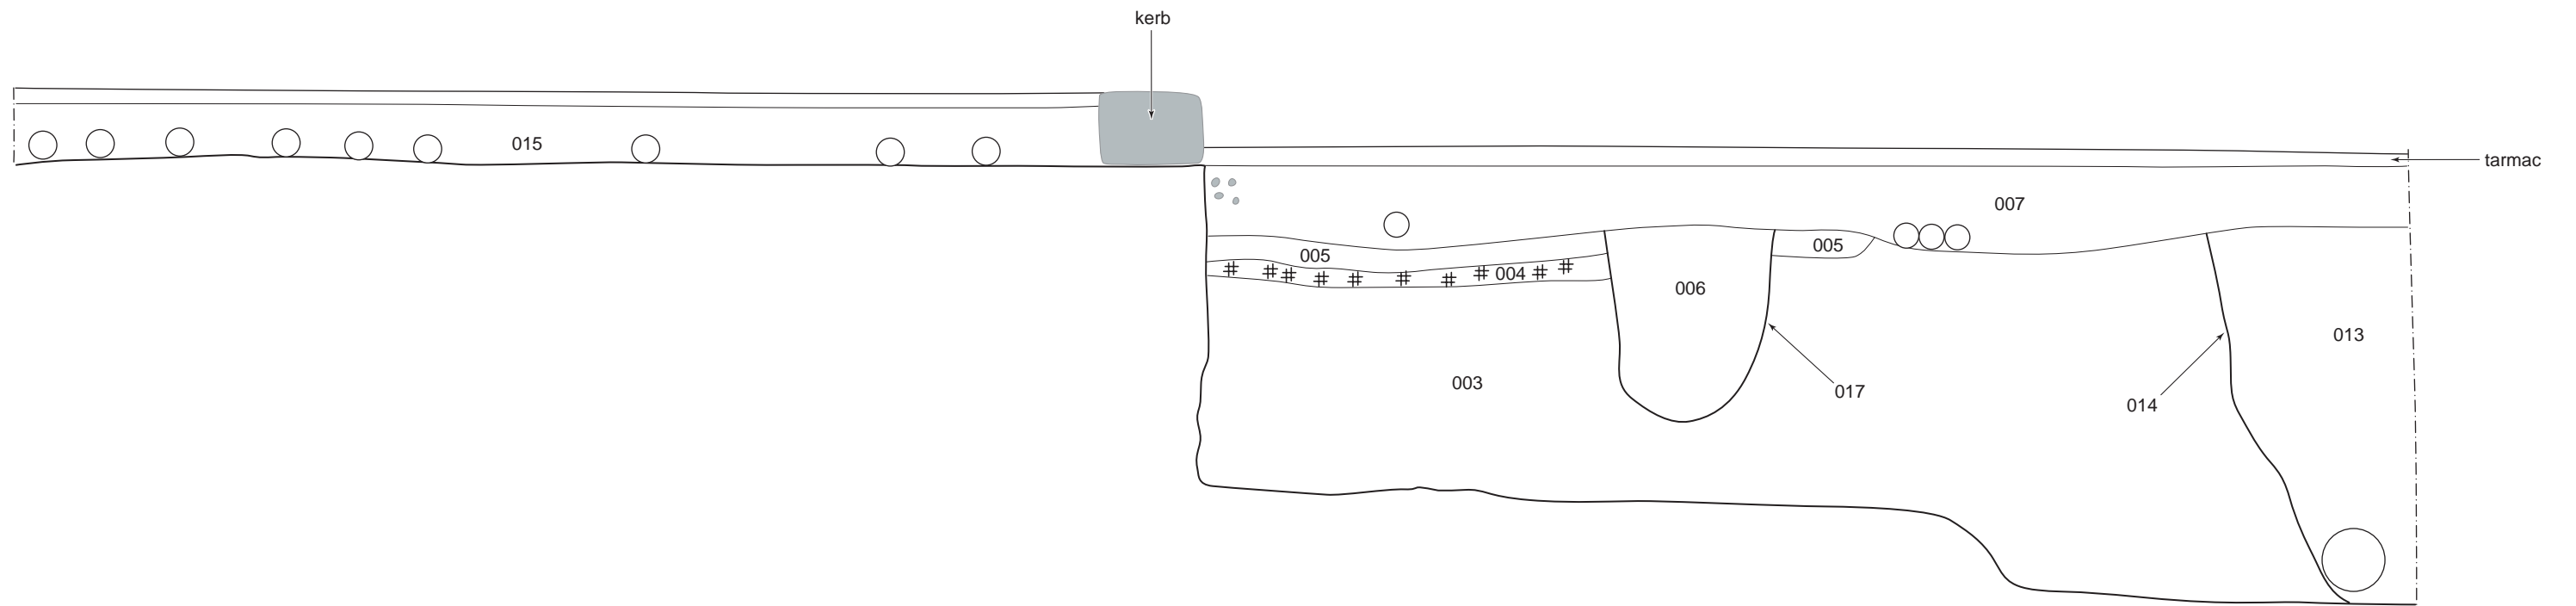
Figure 3 - RPA Slit Trench Monitoring:
E3963, Section of slit trench 728.

ST 728 was located on Stephens Green North, southwest of ST 727. It measured 7.50 m long by 0.60 m wide and was 0.20 m - 1.32 m deep. It was located on both the pavement and carriageway and was orientated in a northeast-southwest direction. Similar to the previously described trench ST 727 a deposit of moderately compact medium brown silty clay (003) with charcoal, stone and red brick inclusions was identified on the carriageway side of the trench. It measured approximately 5 m long by 0.60 m wide with unknown thickness. A thin lens of black charcoal rich silty clay (004) overlay this deposit to the kerb side of the trench (Plate 1). It measured 1.50 m long by 0.60 m wide and was 0.05 m – 0.10 m thick. Directly over this lens was a layer of red brick (005). This possibly formed a surface similar to the red brick surface in ST 727. The brick was degraded and very soft and measured 1.50 m long by 0.60 m wide with a thickness of 0.05 m – 0.10 m. Both the charcoal lens and the brick surface were truncated by a modern pit that contained light brown silt (006). To the south of this trench a further modern utility trench (014), at the base was a utility pipe. The fill of this modern trench (014) comprised of modern sand (013). Directly over this modern utility trench (014) and the possible red brick surface (005), was a modern deposit of moderately compact dark brown silty clay (007) with a moderate amount of stone inclusions. This deposit filled the carriageway side of the trench. Utility pipes were located within this deposit.

Draw No.	Sheet No.	Section	Plan	Scale	Description
1	2	Yes	N/A	1:20	Mid-excavation section of ST 728

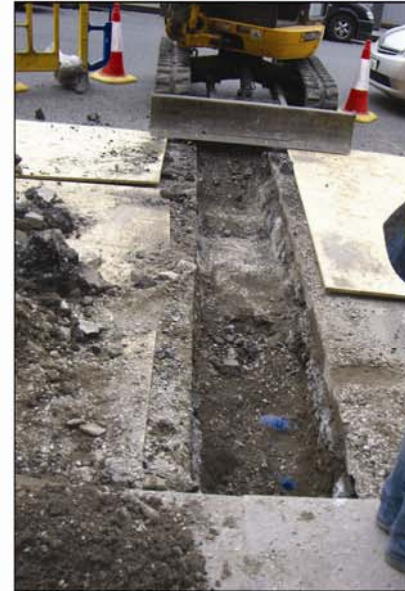
Plate 2 - Mid-excavation of carriageway ST729, Stephens Green north, southwest-facing.

ST 729 was situated in a northeast-southwest direction on Stephens Green North. It was located on both the pavement and carriageway and measured approximately 7 m long by 0.60 m wide and was 0.20 m – 1.30 m deep. Several utility pipes were identified within this trench and no archaeological features were encountered (Plate 2).

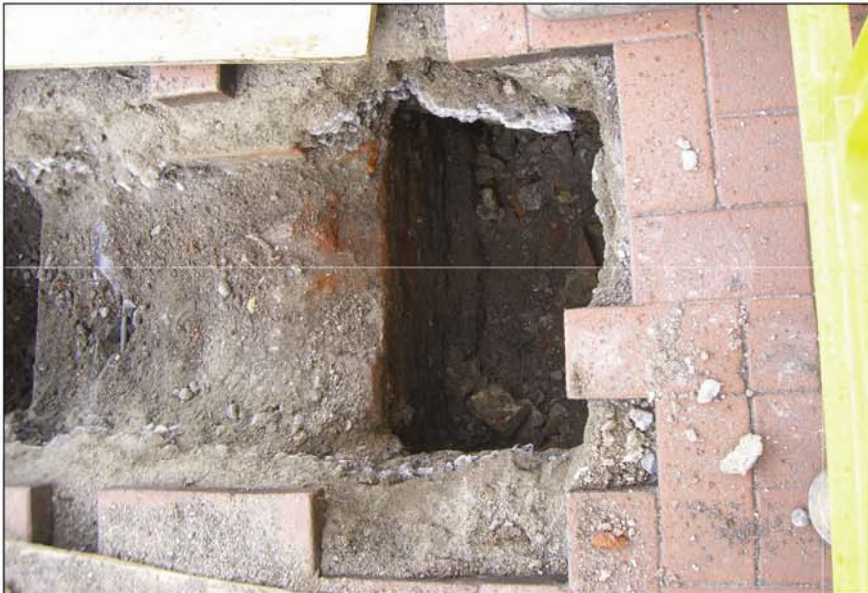
Plate 3 - Mid-ex of ST730, Stephens Green north, west-facing.

ST 730 was situated in a northeast-southwest direction on the pavement of Stephens Green north. It measured 9 m long by 0.60 m wide and was 0.25 m – 0.30 m deep. Several utilities were identified within in this trench. A red brick arch-shaped ceiling of a cellar (008) and a vertical cellar wall were located to the extreme north of the trench (Plate 3). It measured approximately 0.50 m long by 0.60 m wide and lay approximately 0.30 m from the surface. The cellar was backfilled with building rubble (009).

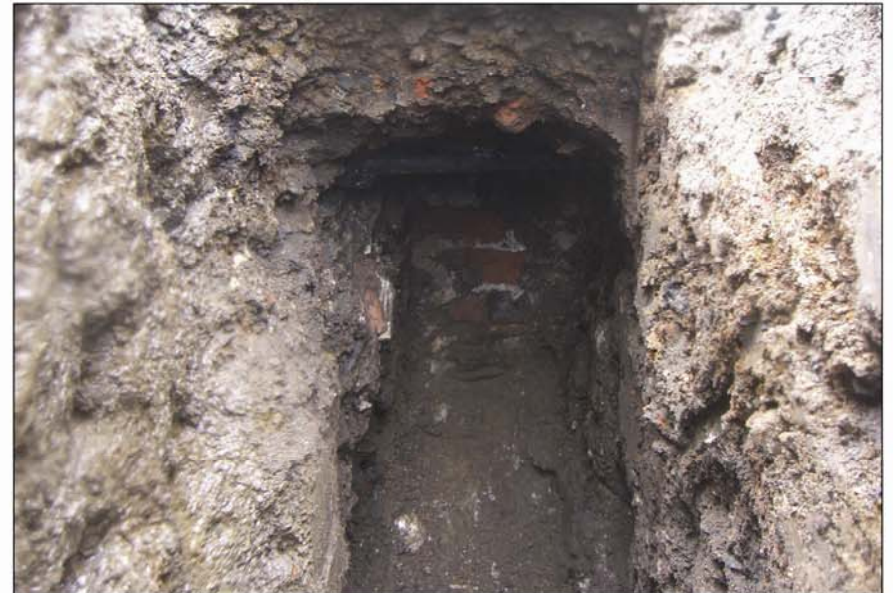
Plate 4 - Mid-excavation of ST731, Grafton St., northeast-facing.

This trench was located in a northeast-southwest direction to the southern end of Grafton Street at the junction with St Stephens Green North and West. The trench measured 10 m long by 0.60 m wide and was 0.50 m – 1 m deep. Several utilities were located in this trench. A wall of red brick (010) was located to the extreme north of the trench (Plate 4). It represented a cellar wall and it was situated approximately 0.30 m from the surface. No archaeological features or deposits were identified within this trench.
