**Project code: RPLT08**

Client: Railway Procurement Agency

## **Report on Archaeological Testing of Luas Line A1 Belgard to Saggart, Co.Dublin.**

Licence No: 08E0792

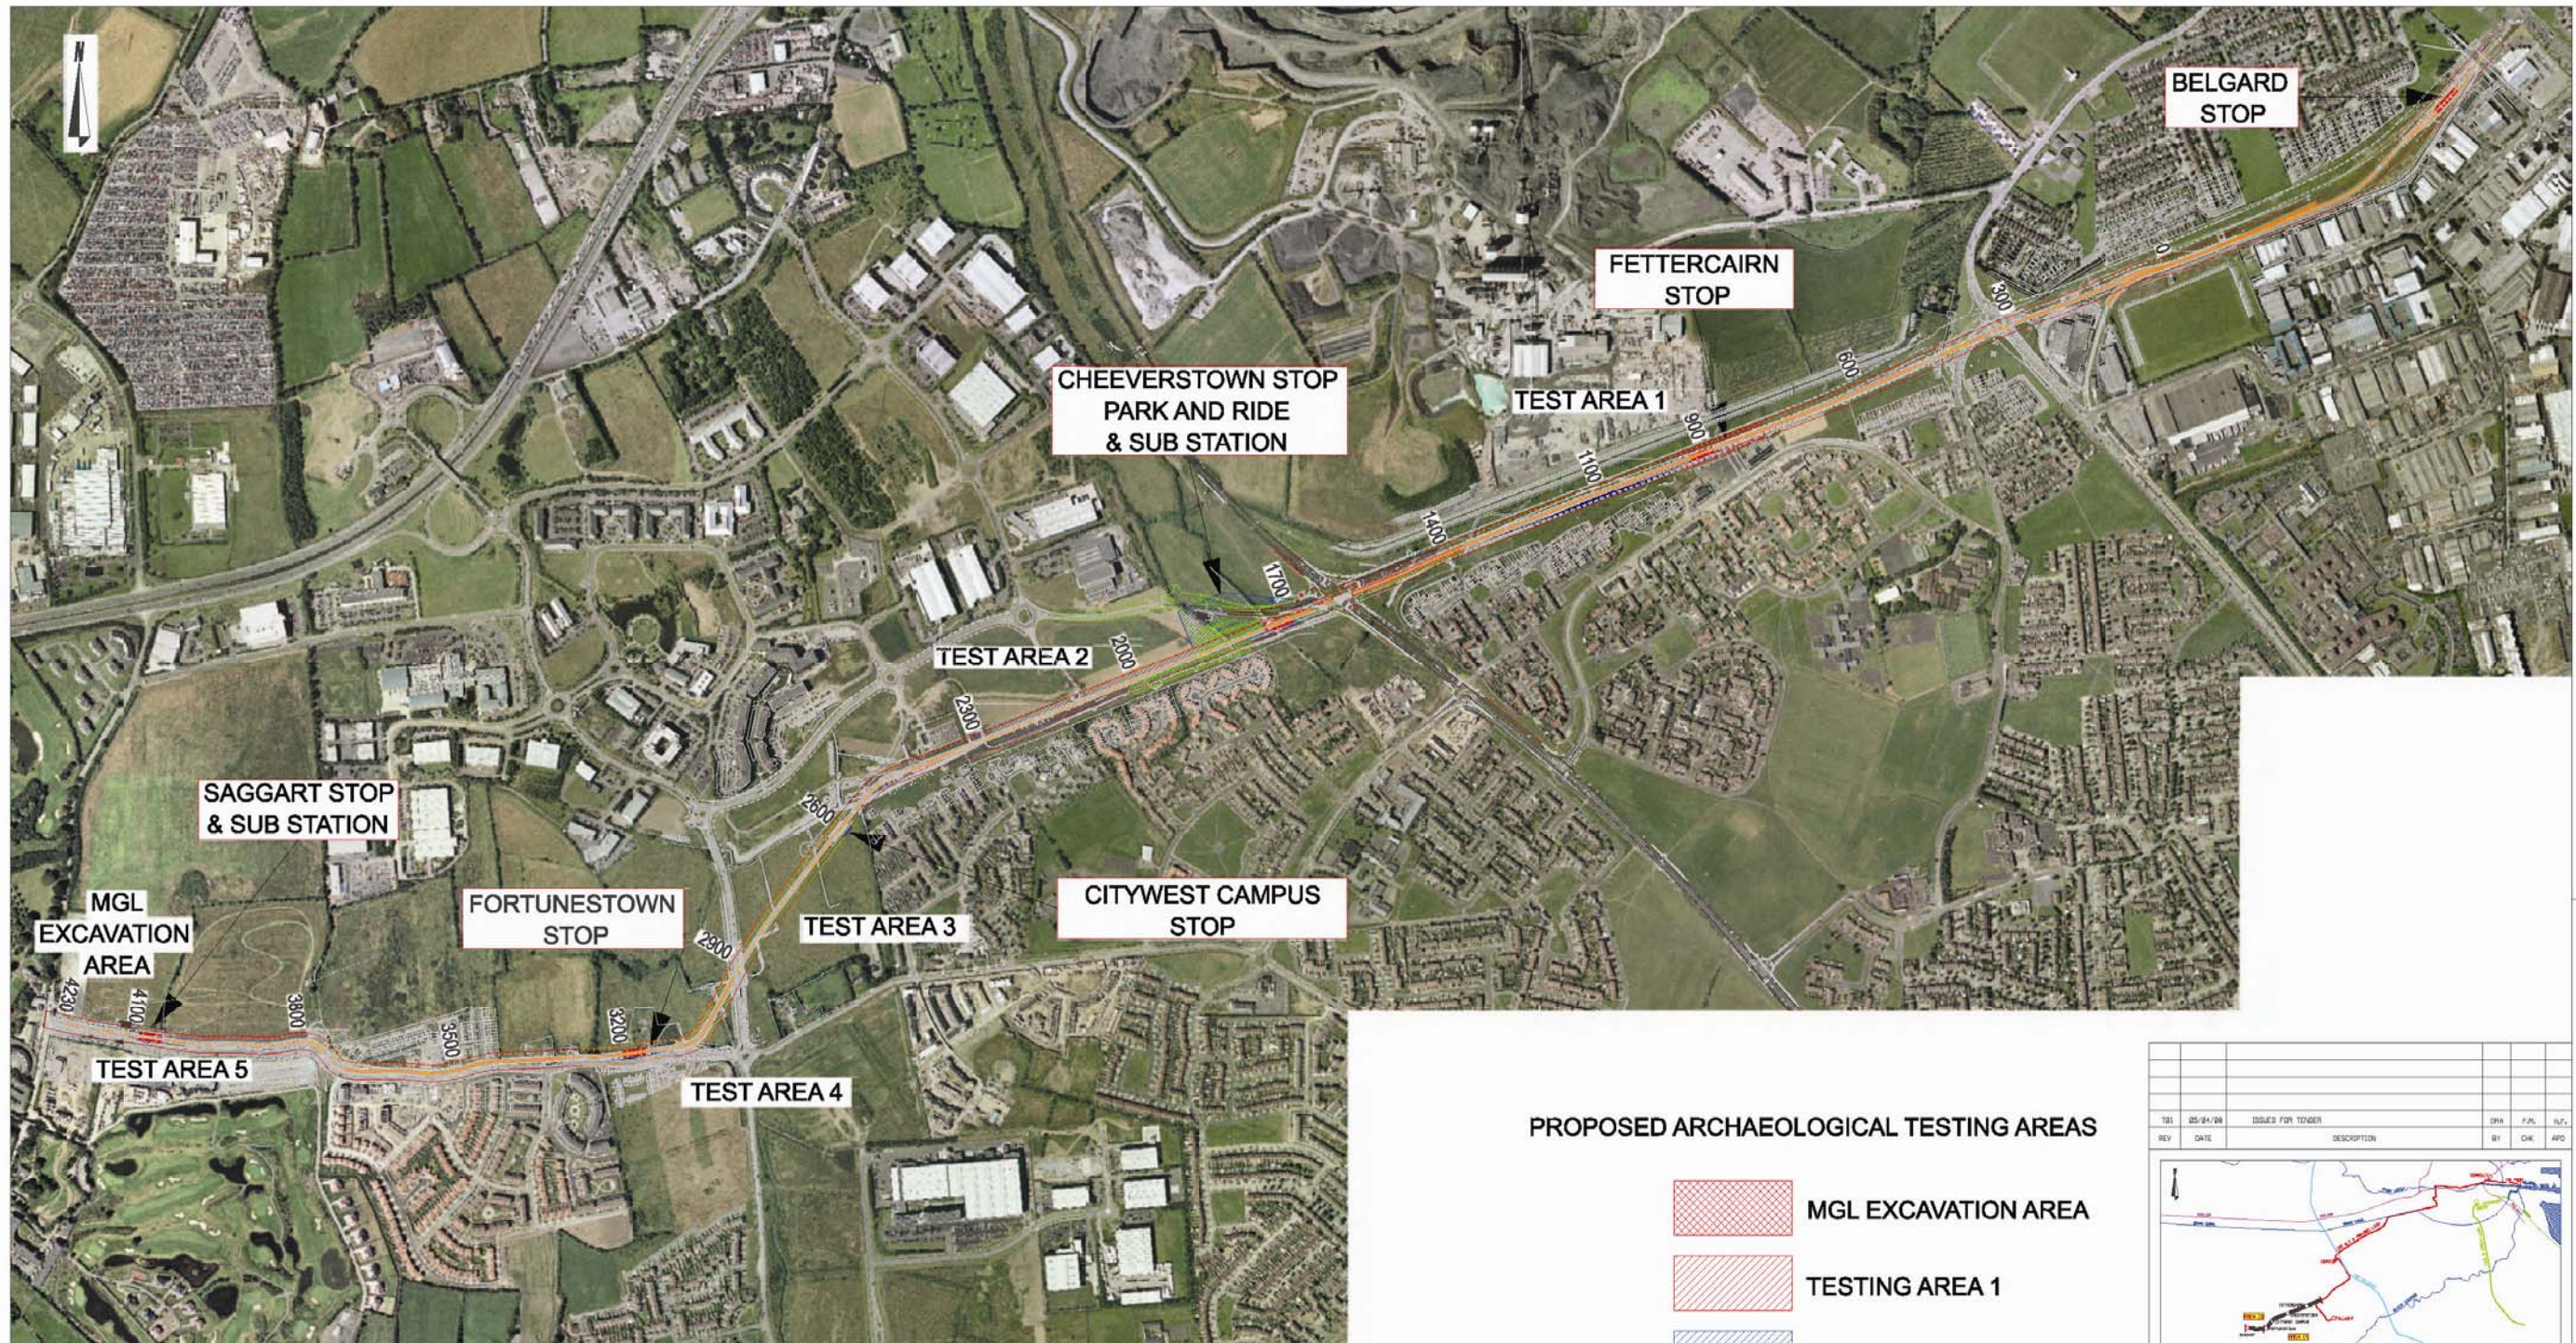
Figure 2 - Luas Red Line (A1):Belgard to Saggart, Co. Dublin: Archaeological Testing Areas

The route has been divided into five separate areas, for ease of recognition and description. These Testing Areas are :

Testing Area 1: Total area of 4830m<sup>2</sup>. Located between CH 780 to CH 960 and represents the footprint for the Fettercairn stop, (figure 3).

Testing Area 2: Total area of 38861m<sup>2</sup>. Located between CH 1670 to CH 2550 and represents the footprint for the Cheeverstown stop, (figure 4).

Testing Area 3: Total area of 10074m<sup>2</sup>. Located between CH 2550 to CH 2890 and represents the footprint for the City West Campus stop, (figure 5).

Testing Area 4: Total area of 4291m<sup>2</sup>. Located between CH 2920 to CH 3100, (figure 5).

Testing Area 5: Total area of 4763m<sup>2</sup>. Located between CH 3790 to CH 4050 and represents the footprint for the Saggart stop, (figure 6).

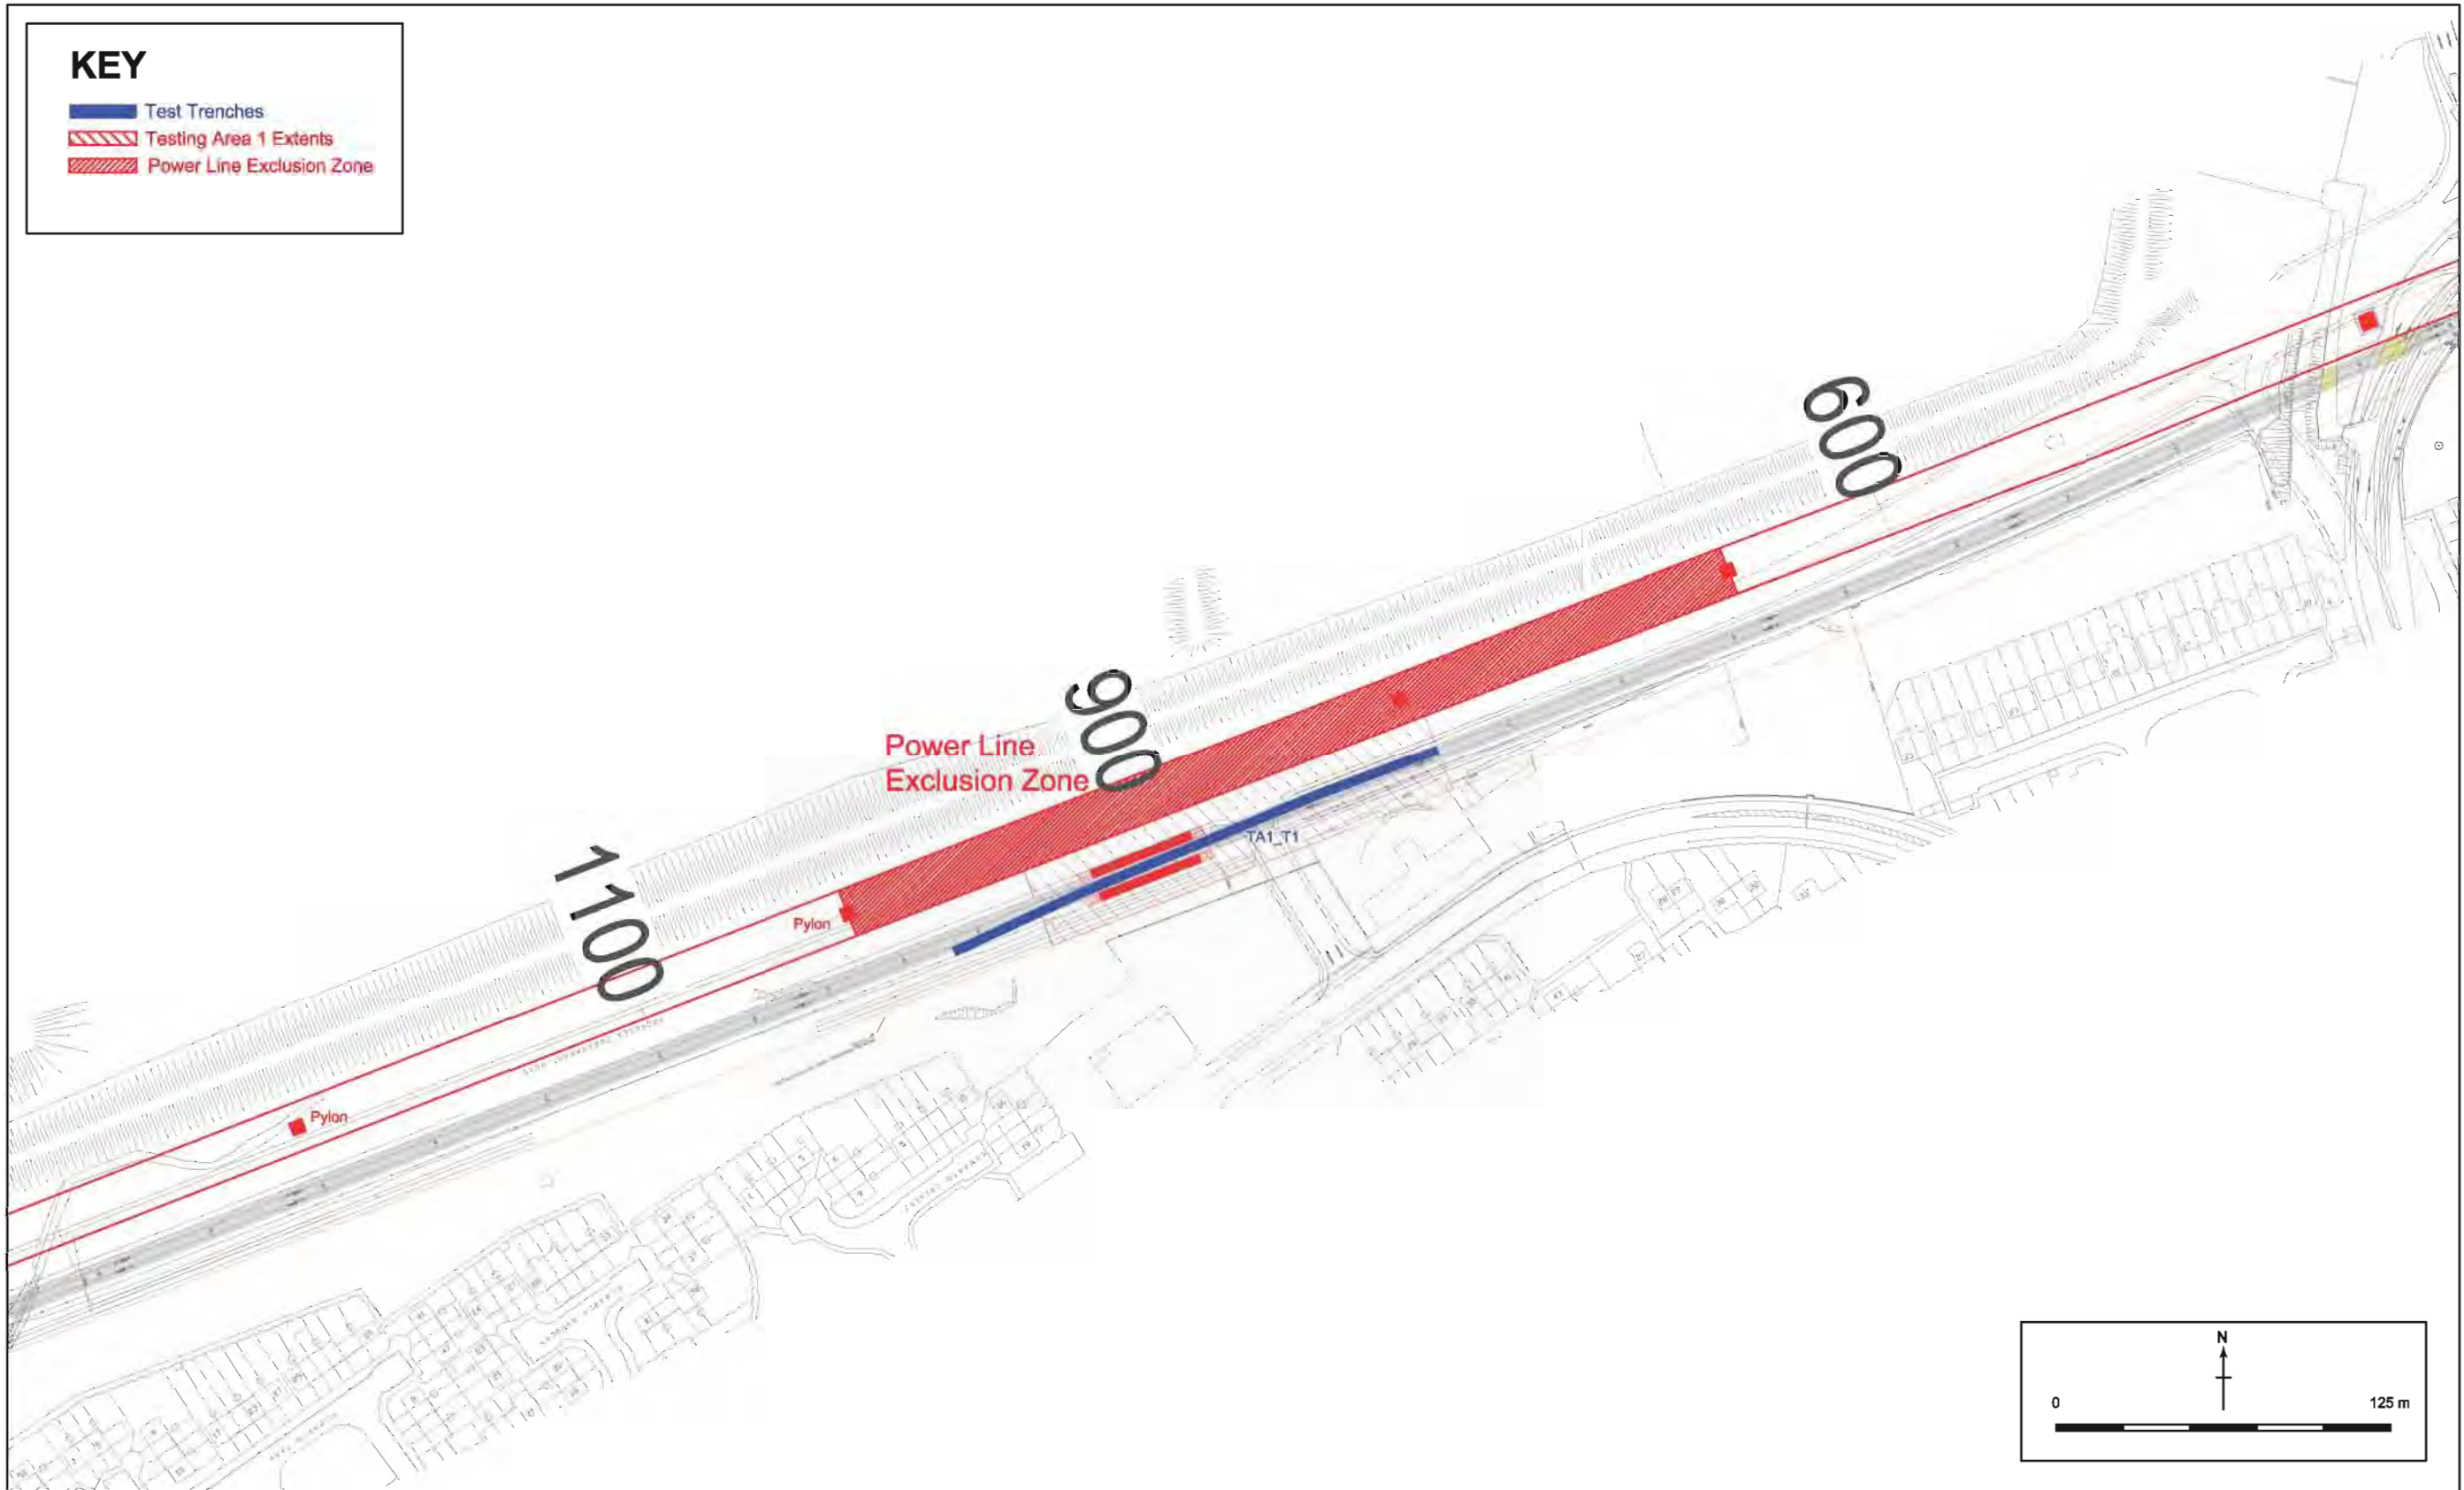
Figure 3 - Luas Line A1 Centreline Testing, Testing Area 1 Trench Layout, Fettercairn Stop.

Trench 1(TA1/T1) was 196 m long, 3.8m wide, with a minimum depth of 0.10m and a maximum depth of 0.90m. The overlying topsoil (001) was a brown sandy silt with very frequent inclusions of modern domestic debris throughout, including electrical appliances and automobile parts, plastic and construction waste, 0.70m deep (max). The subsoil (002) was compact yellow brown silty clay with frequent small and medium sized stones. This area traverses the former location of the townland boundary between Whitehall and Cheeverstown, however no traces of features relating to this were revealed. No features of archaeological significance were found and the trench was reinstated.

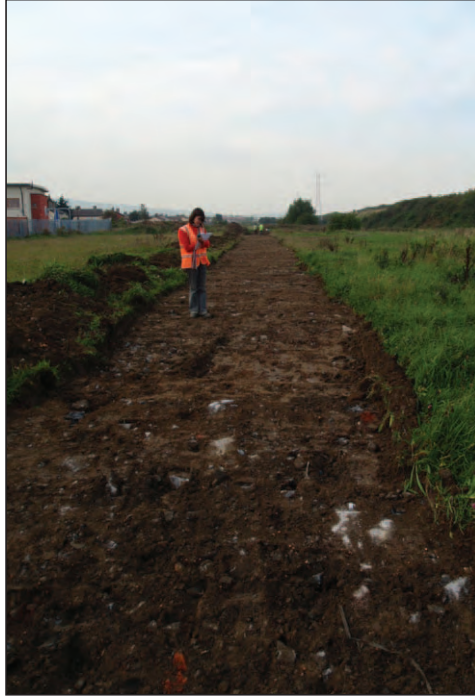
Plate 1 - Testing area 1, trench 1, facing southwest.

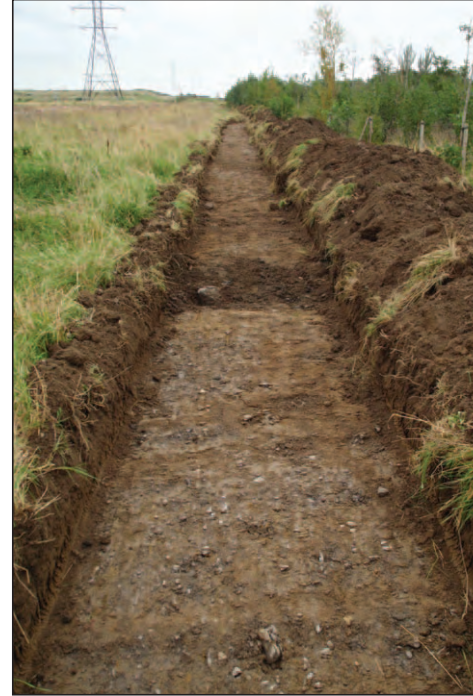
wide. Both of these features ran towards above ground water mains access and were also found in trench B, which ran parallel to trench A. Both of these features and their fills (004, 006) were considered modern, due to the amount of modern debris, and of no archaeological significance.

Plate 2 - Testing area 2, trench 2, water mains trench, (003), facing northeast.

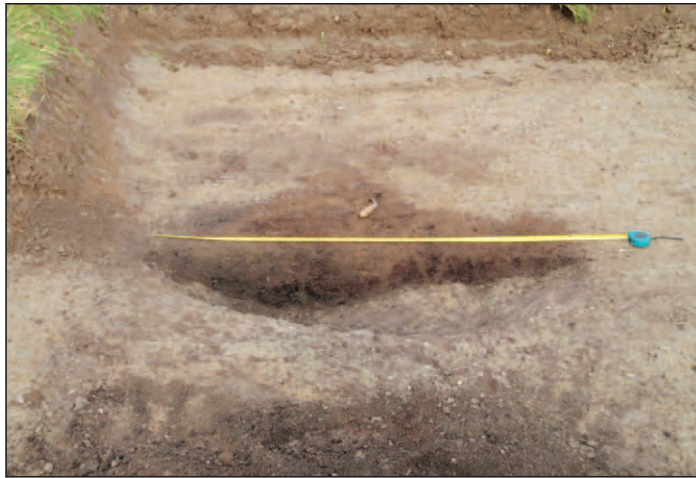
Trench 5 (TA2/T5) was 49.2m long, 1.9m wide, with a maximum depth of 0.40m and a minimum depth of 0.35m. One possible feature was found in this trench, (011) an irregular sub oval shaped pit with gradually sloping sides and an irregular base, 1.5m long, 0.70m wide, 0.25m deep, which, when sectioned, proved to be a natural feature with decomposed brown and black organic matter and no inclusions (012). Modern agricultural furrows (C.015) and a stone filled drainage feature (C.013) ran in a general north/south orientation through this trench and trenches 6, 8 and 9. No features of archaeological significance were uncovered.

Plate 3 - Testing area 2, trench 5, (011), natural; feature, facing north.

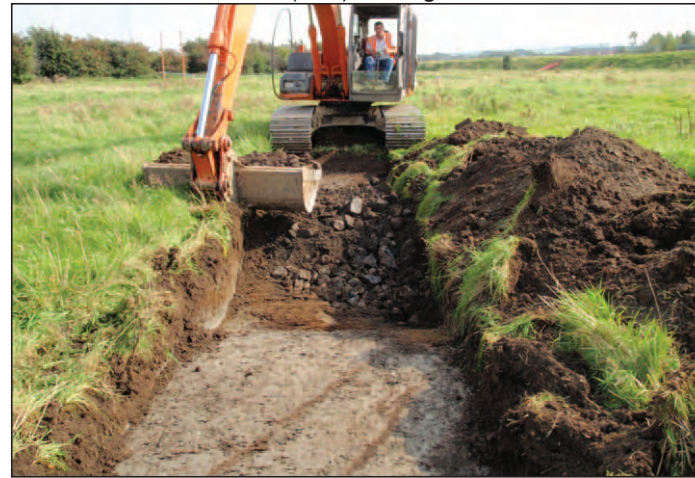
Plate 4 - Testing area 2, trench 5, (013), modern stone filled drain, facing east

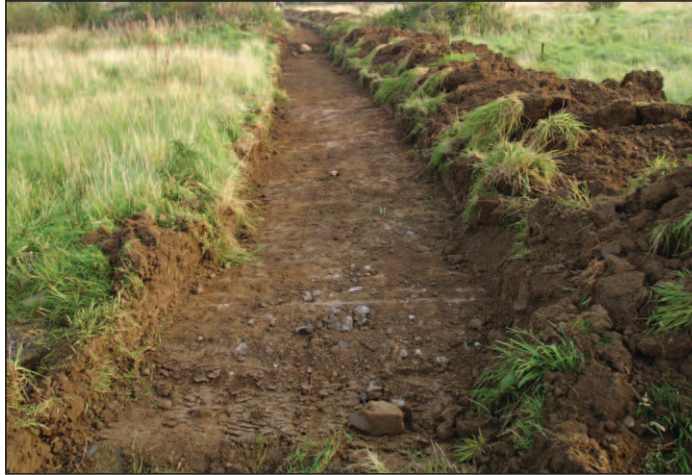
Plate 5 - Testing area 3, trench1, facing southwest

Trench 1(TA3/T1) was 290.8 m long, 145m was 1.9m wide and c.145m was 3.8m wide (figure 5) with a maximum depth of 0.60m and a minimum depth of 0.30m.

and abandoned or burnt. Two such features were noted in TA3/T1 (figure 5). The overlying topsoil (001) was mid brown sandy silt with small to medium sized stones and roots, 0.35m deep. The subsoil (002) was yellow brown silty clay with frequent small stones. No features of archaeological significance were found and the trench was reinstated.

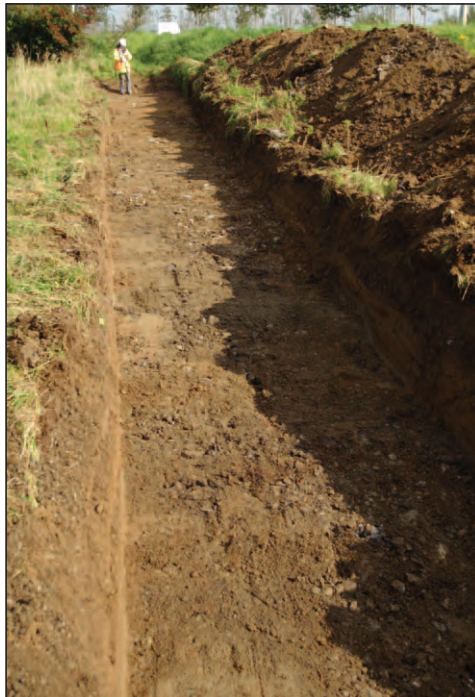
Plate 6 - Testing area 4, trench 3, facing southwest.

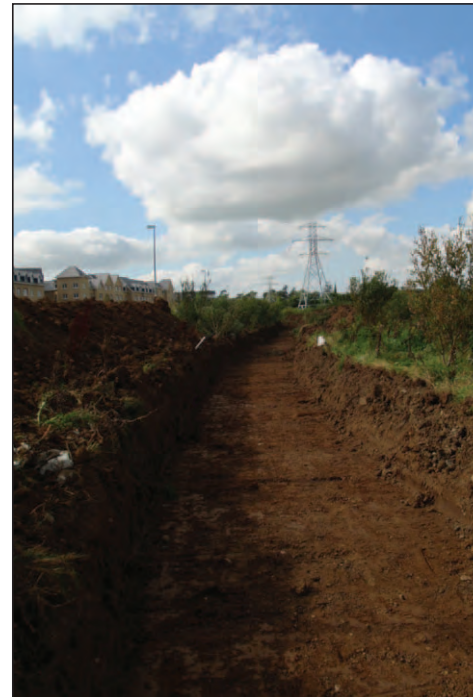
Plate 7 - Testing area 5, trench 1, facing west.

Trench 1 (TA5/T1) was 151.4m long, 3.8m wide, with a maximum depth of 1.00m and a minimum depth of 0.60m. A test pit from the geotechnical investigations conducted by AGL Consulting (2006) was found in TA5/T1 (figure 6). No features of archaeological significance were uncovered and the trench was reinstated.
