**Assessment Report on the Results of Metro North  
Advance Archaeological Test Trenching,  
Testing Area 6, Lissenhall Little and Balheary  
Demesne townlands, Co. Dublin,  
RPA ref: (MN101) Lissenhall to Fosterstown**

**Excavation Licence Number:** 09E464  
**Director:** John Channing  
**Report Author:** John Channing and James Hession  
**Project Code:** RPMN08  
**Client:** Railway Procurement Agency RPA 7120\_5  
**Townlands:** Lissenhall Little  
**Ordnance Datum:** 12 m  
**NGR:** 318743, 248525

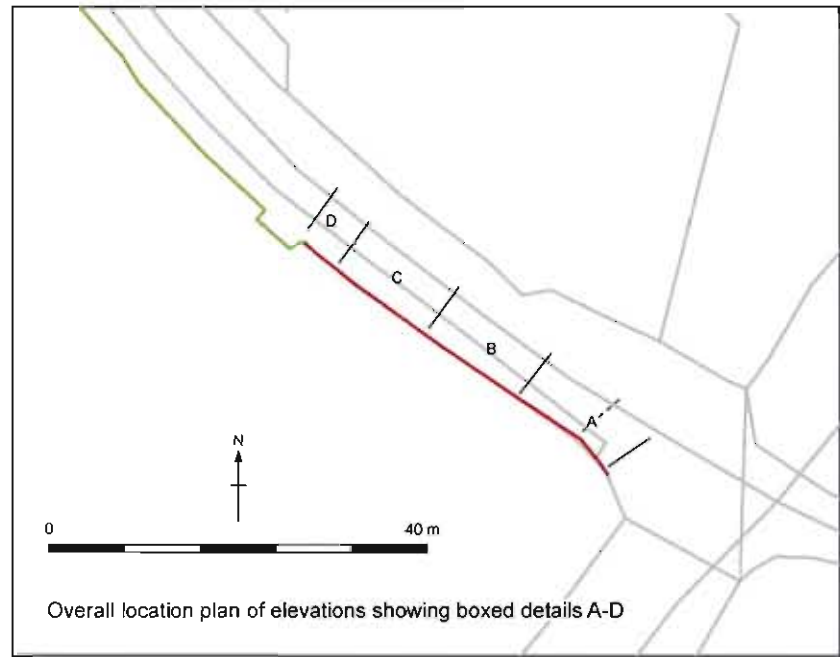
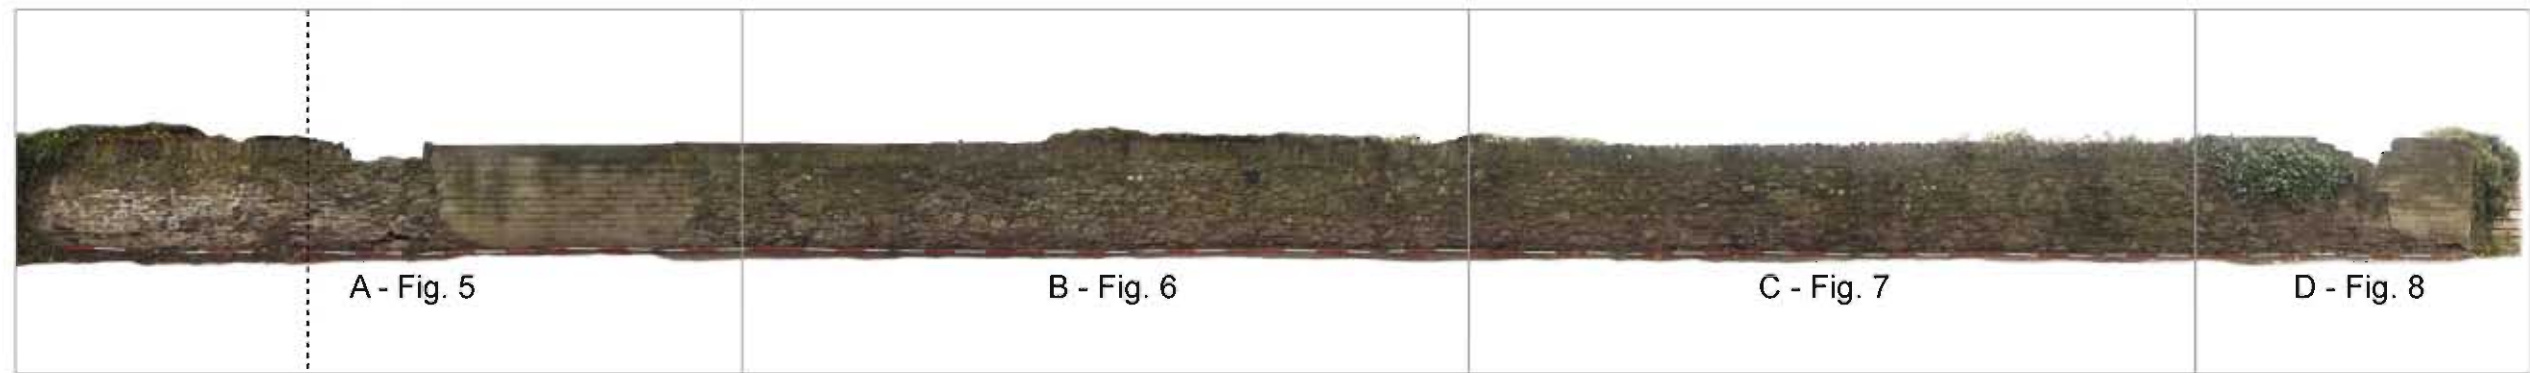
Figure 4 - Advance Archaeological Test Trenching of Metro North: Testing Area 6, Lissenhall Little and Balheary Demesne townlands, Co. Dublin, RPA ref: (MN101) Lissenhall to Fosterstown Overall elevation of townland boundary wall HC#414, showing boxed details

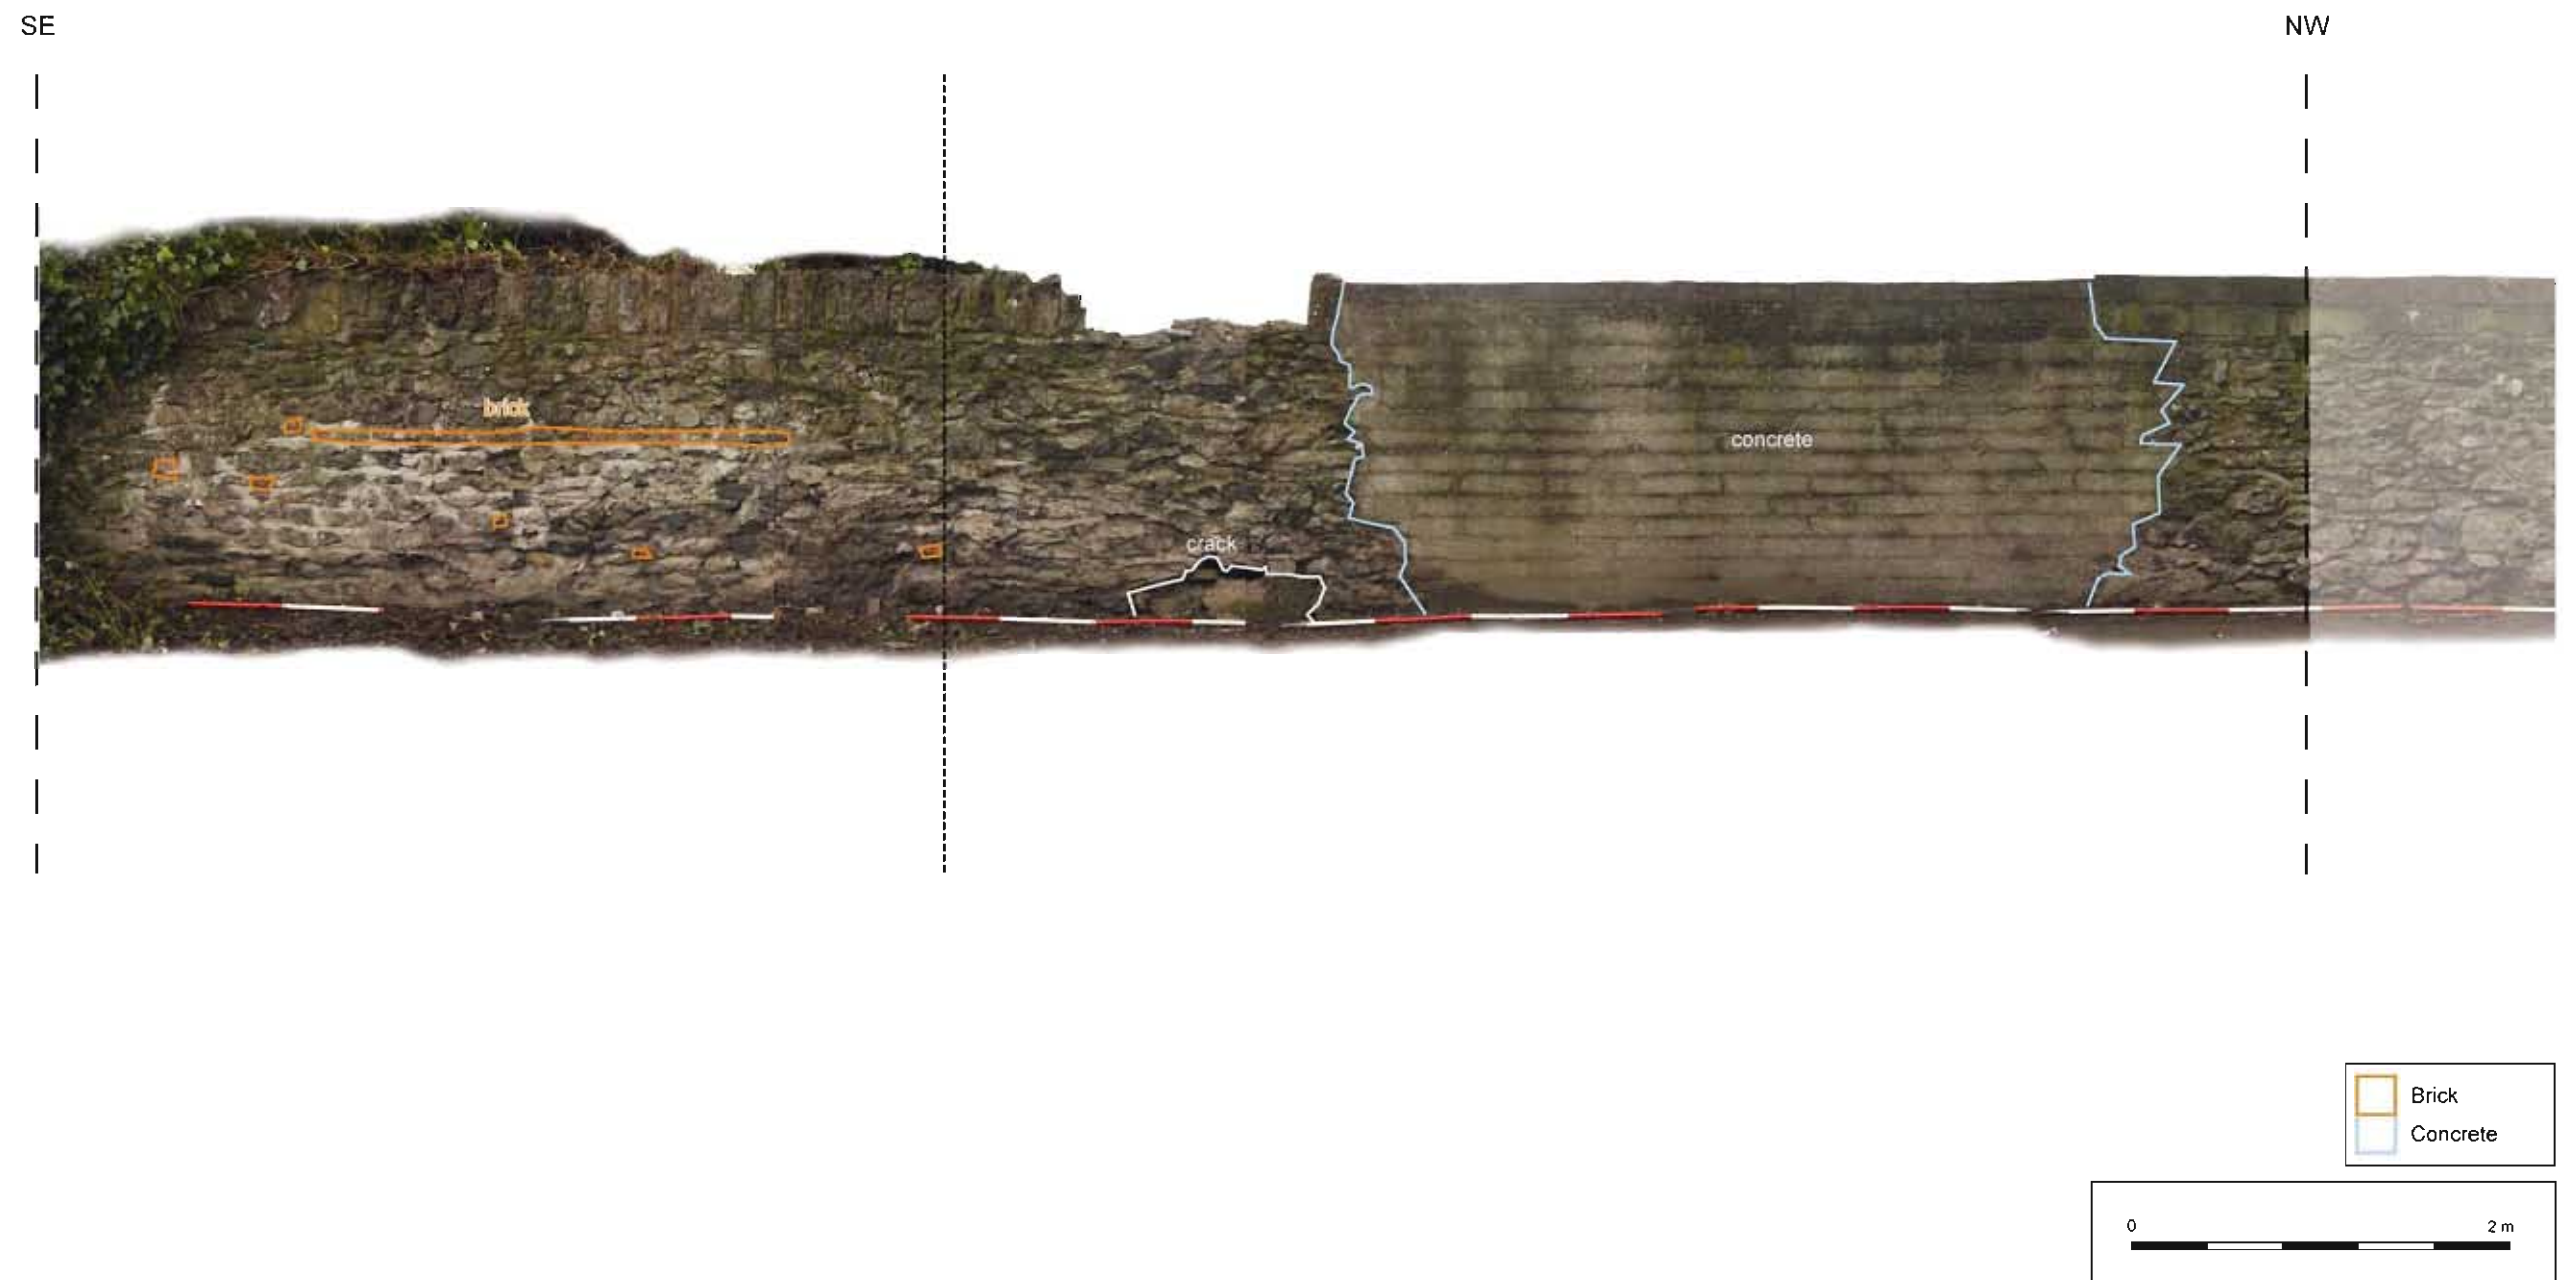
Figure 5 - Advance Archaeological Test Trenching of Metro North: Testing Area 6, Lissenhall Little and Balheary Demesne townlands, Co. Dublin, RPA ref: (MN101) Lissenhall to Fosterstown Townland boundary wall HC#414: Northeast-facing elevation, Detail A.

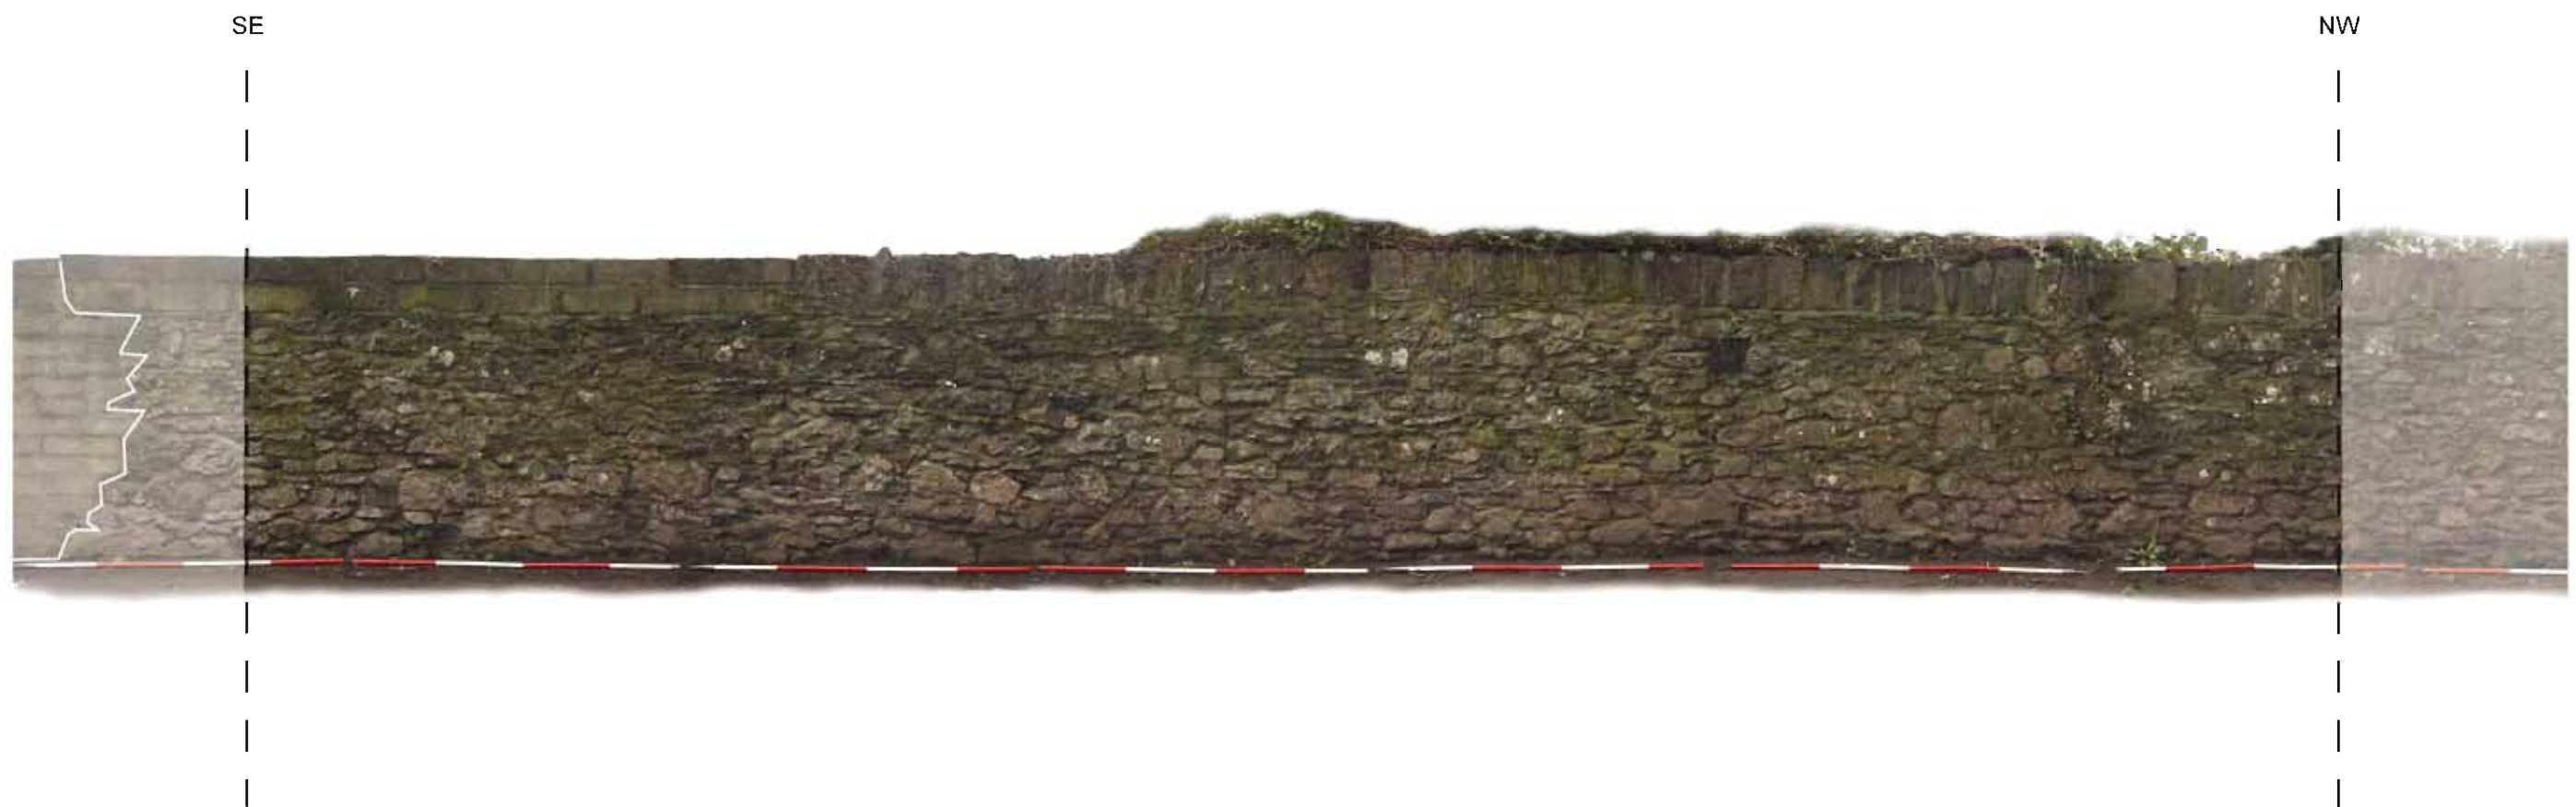
Figure 6 - Advance Archaeological Test Trenching of Metro North: Testing Area 6, Lissenhall Little and Balheary Demesne townlands, Co. Dublin, RPA ref: (MN101) Lissenhall to Fosterstown Townland boundary wall HC#414: Northeast-facing elevation, Detail B.

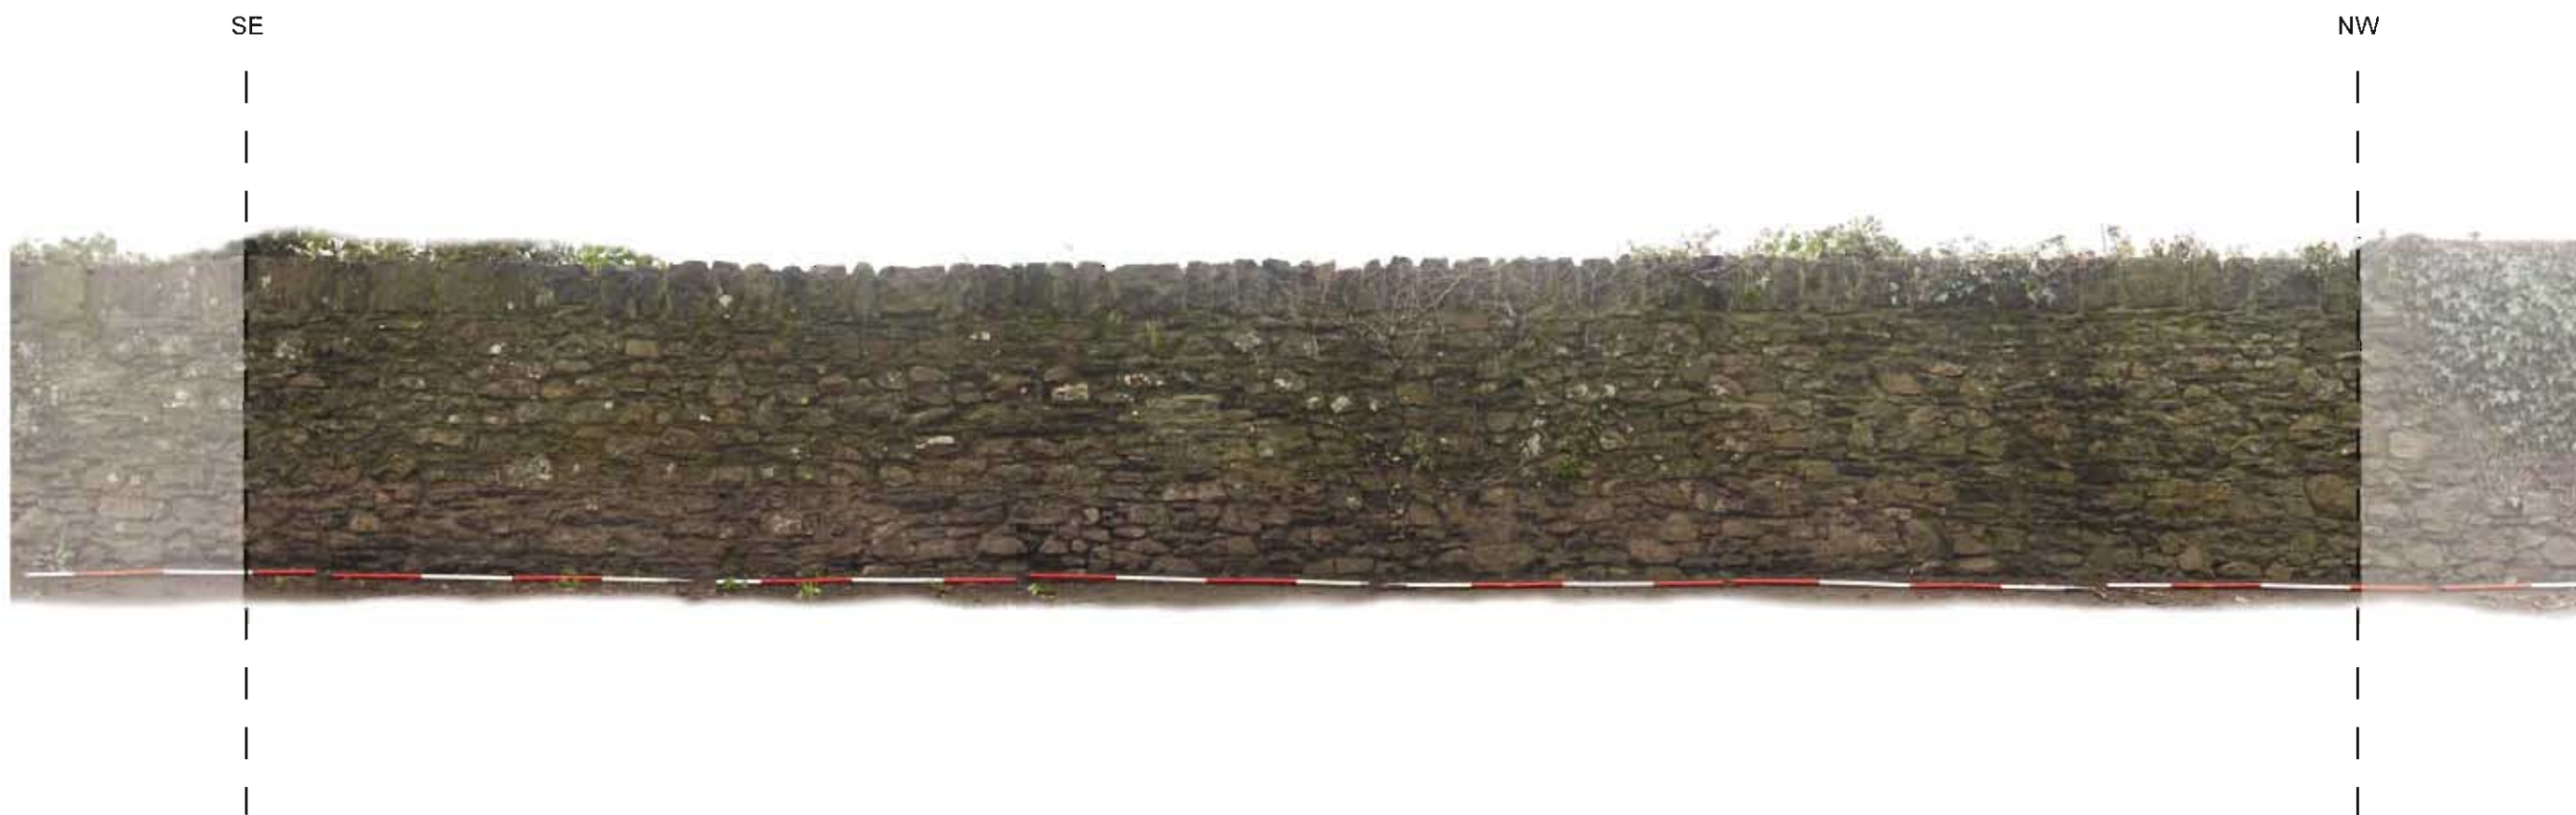
Figure 7 - Advance Archaeological Test Trenching of Metro North: Testing Area 6, Lissenhall Little and Balheary Demesne townlands, Co. Dublin, RPA ref: (MN101) Lissenhall to Fosterstown Townland boundary wall HC#414: Northeast-facing elevation, Detail C.

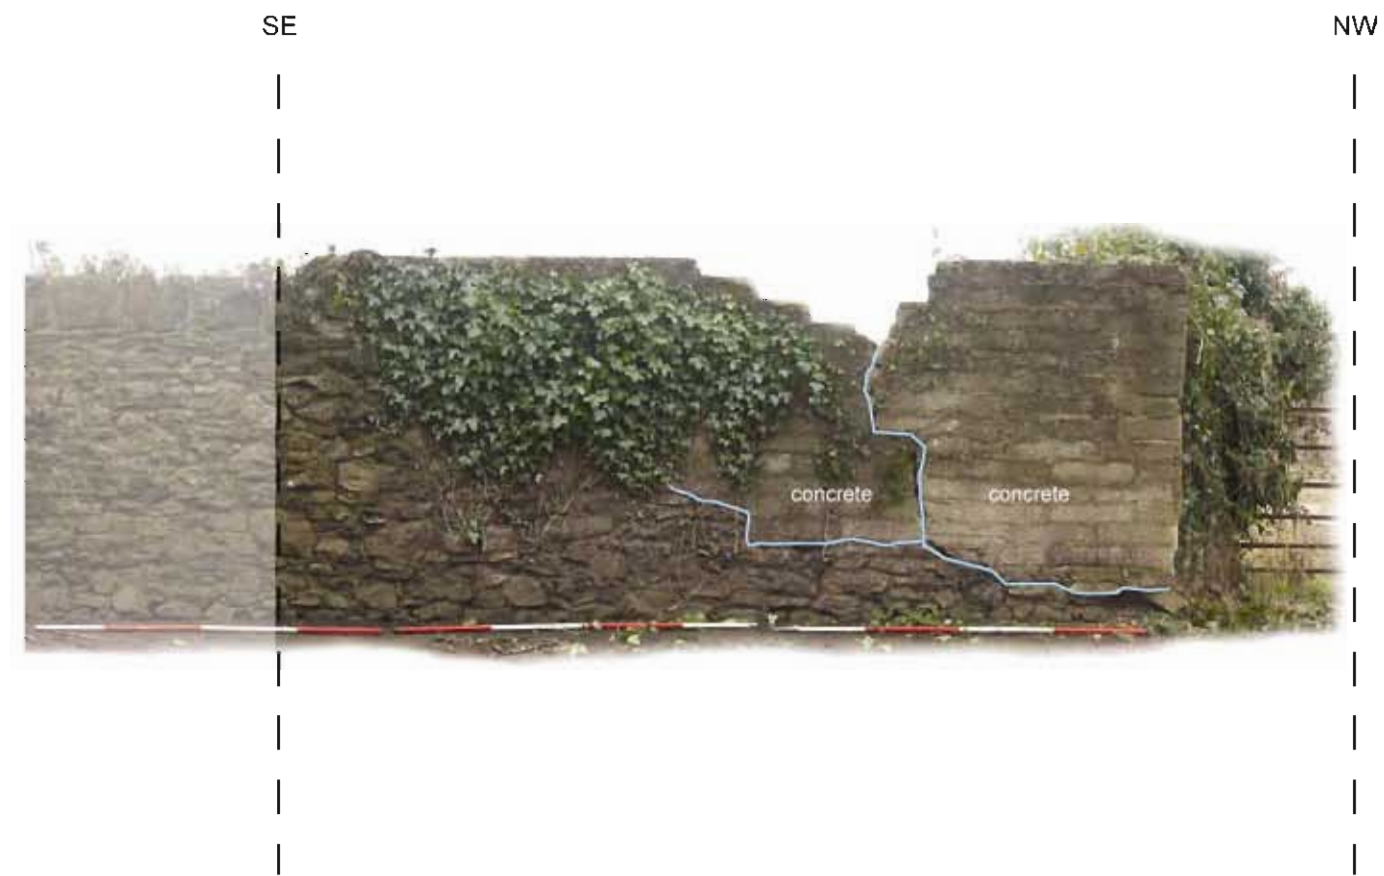
Figure 8 - Advance Archaeological Test Trenching of Metro North: Testing Area 6, Lissenhall Little and Balheary Demesne townlands, Co. Dublin, RPA ref: (MN101) Lissenhall to Fosterstown Townland boundary wall HC#414: Northeast-facing elevation, Detail D.

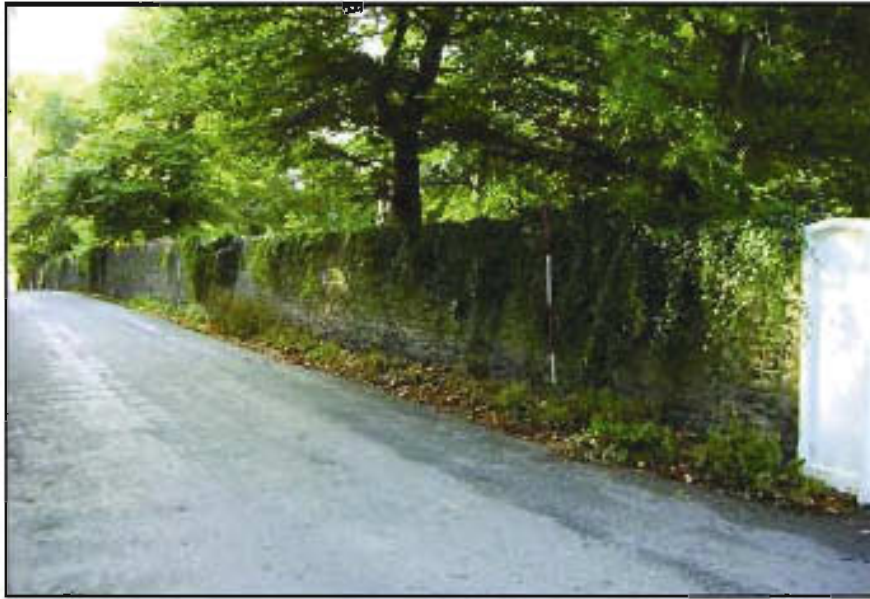
A survey of the townland boundary between Lissenhall Little and Balheary Demesne (HC#414) was carried out along the southwestern side of Testing Area 6 (Figures 4-8; Plates 1-6). The boundary consisted of a stone wall measuring between 1.83 m and 2.02 m in height, with a width of 0.40 m. The wall followed the course of a local road (Ennis Lane; Plate 1) upon which the boundary line is based. The grounds of the Emmaus retreat centre, as well as agricultural land, were located to the south. The wall itself consisted of uncoursed, large limestones, which averaged 0.30 m x 0.15 m x 0.10 m and were bonded with cement. On top of these was a single course of large cut, trapezoidal-shaped limestone slabs, which had been set vertically onto the wall to a height of 0.30 m. The wall was covered in sections by ivy (*Hedera helix*), a likely coloniser rather than a deliberate cultivar, which was growing from its southern side. No other flora was present.

Plate 1 - General view looking southwest along Ennis Lane to townland boundary between Lissenhall Little and Balheary Demesne (HC#414).

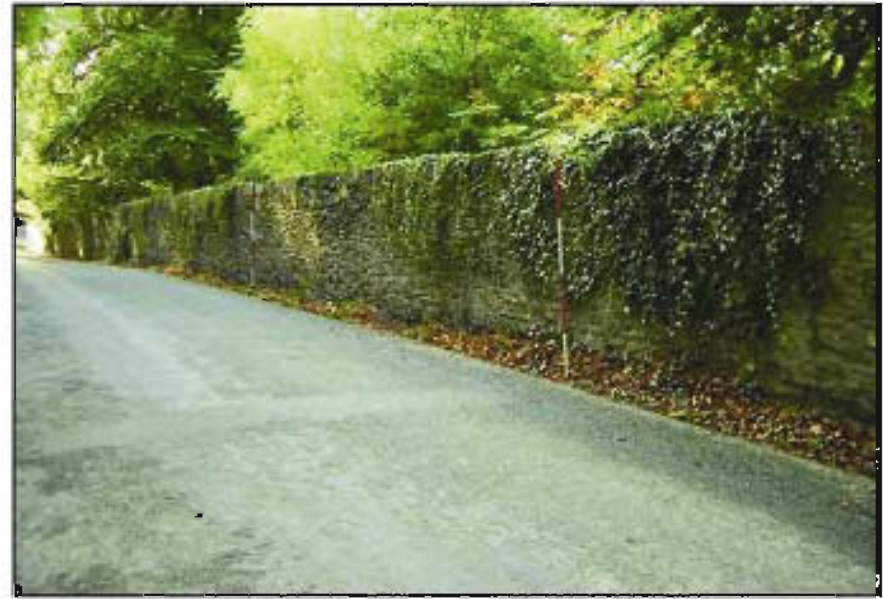
Plate 2 - Measurement point 1 on townland boundary (HC#414).

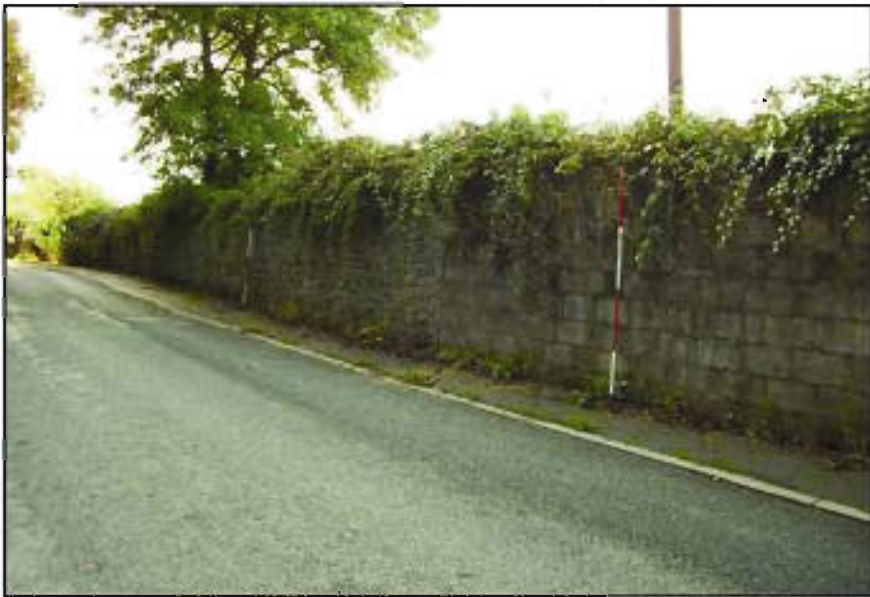
Plate 3 - Measurement point 2 on townland boundary (HC#414).

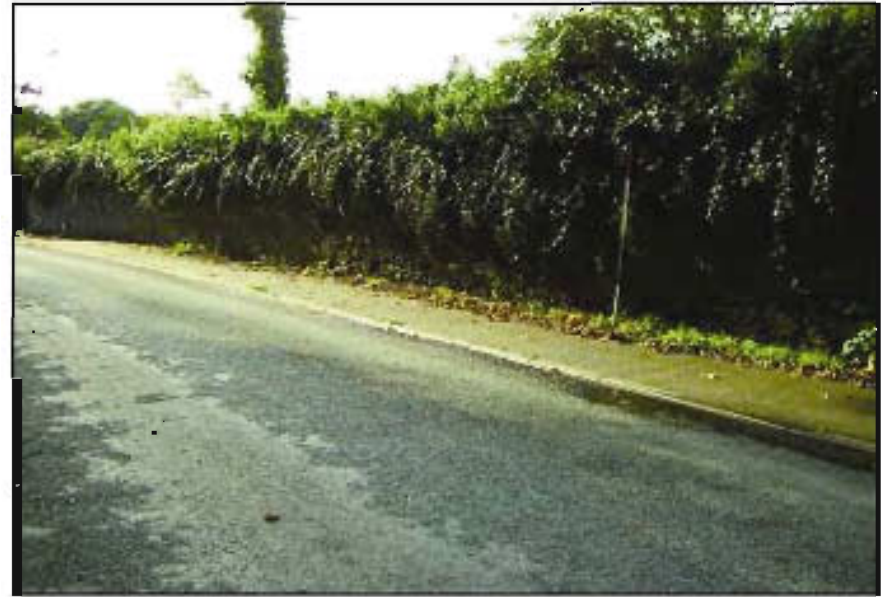
Plate 4 - Measurement point 3 on townland boundary (HC#414).

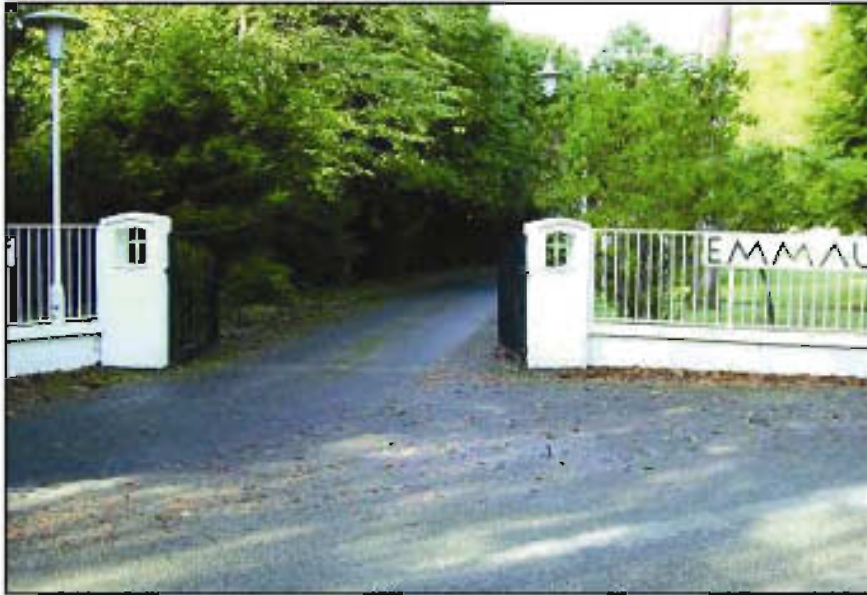
A number of breaks were present in the wall. Two of these were entrances to the Emmaus retreat centre (Plates 5), with an access gate to a field also noted. The only modern alteration noted to the boundary wall were sections of repair and the blocking up of entrances using concrete blocks.

Plate 5 - Entrance to Emmaus retreat centre in the townland boundary wall (HC#414).

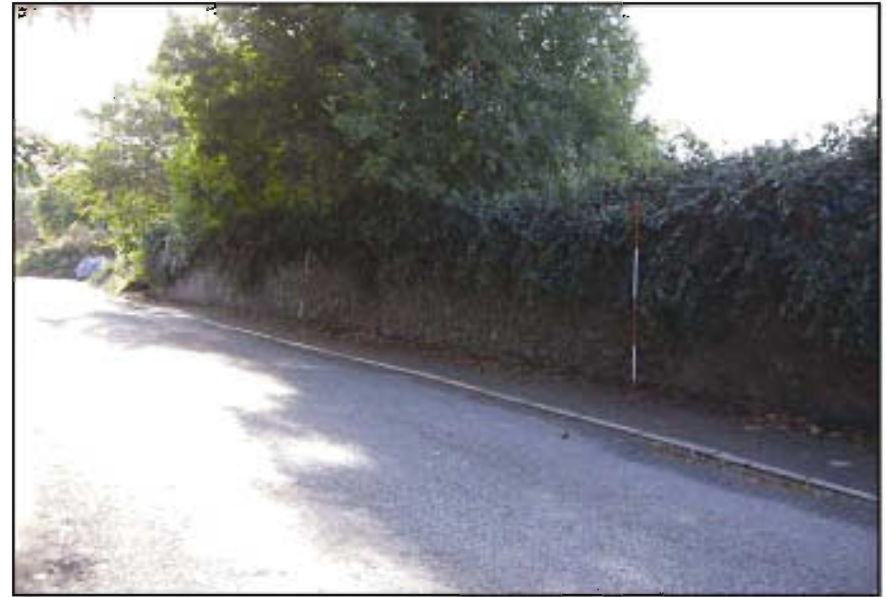
Plate 6 - General view looking southwest along Ennis Lane to townland boundary between Lissenhall Little and Balheary Demesne (HC#414).

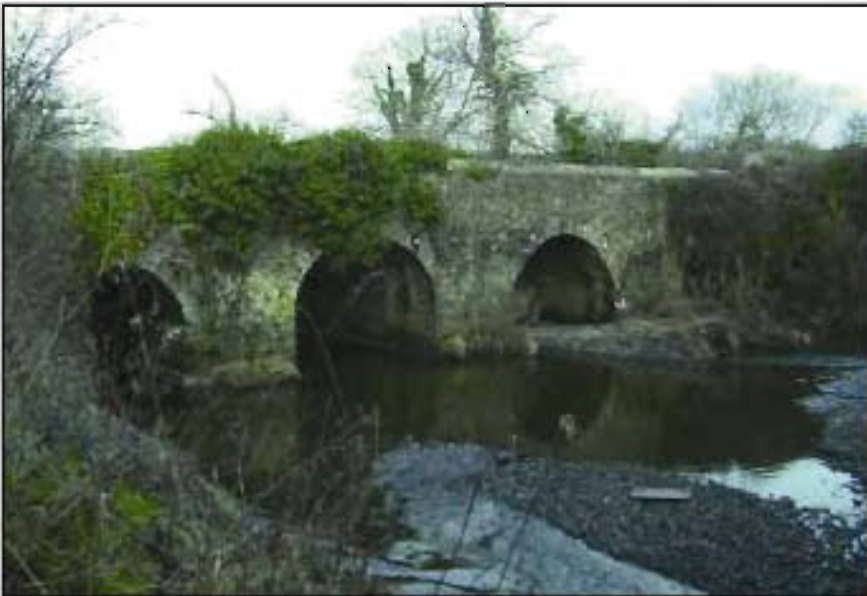
Plate 7 - Photograph of Lissenhall Bridge (HC#11), facing northwest.

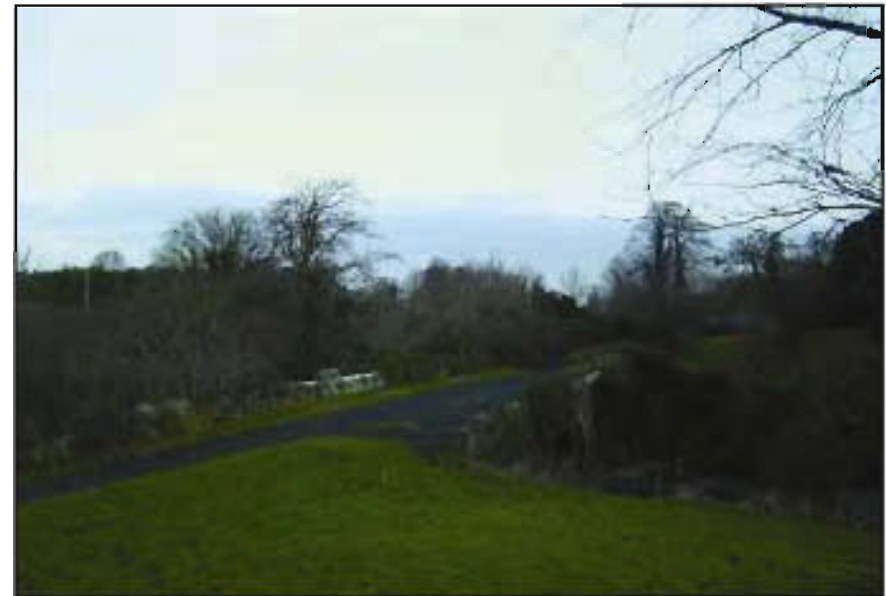
Plate 8 - Photograph of Lissenhall Bridge (HC#11), facing northwest .

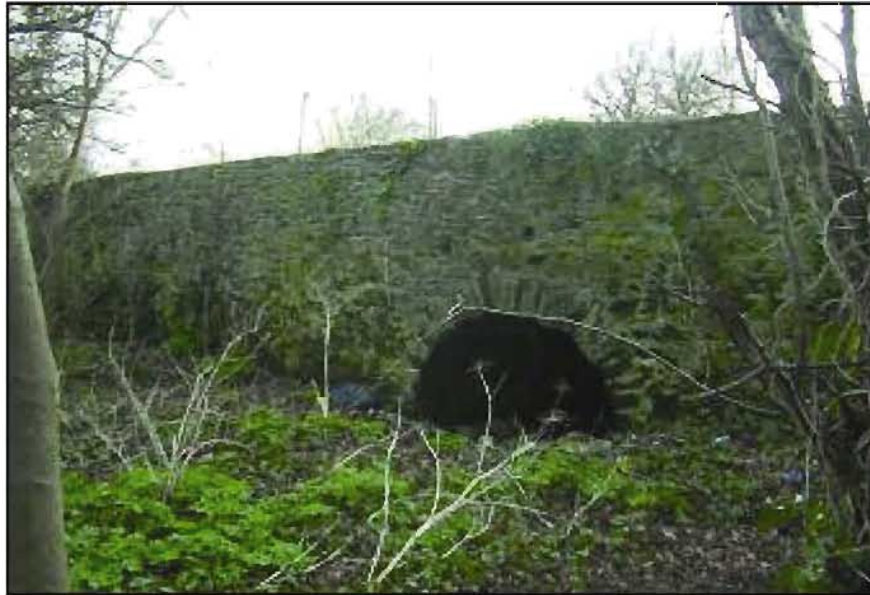
Plate 9 - Photograph of visible arch/culvert within existing western wall of Lissenhall Bridge (HC#11), facing northeast.

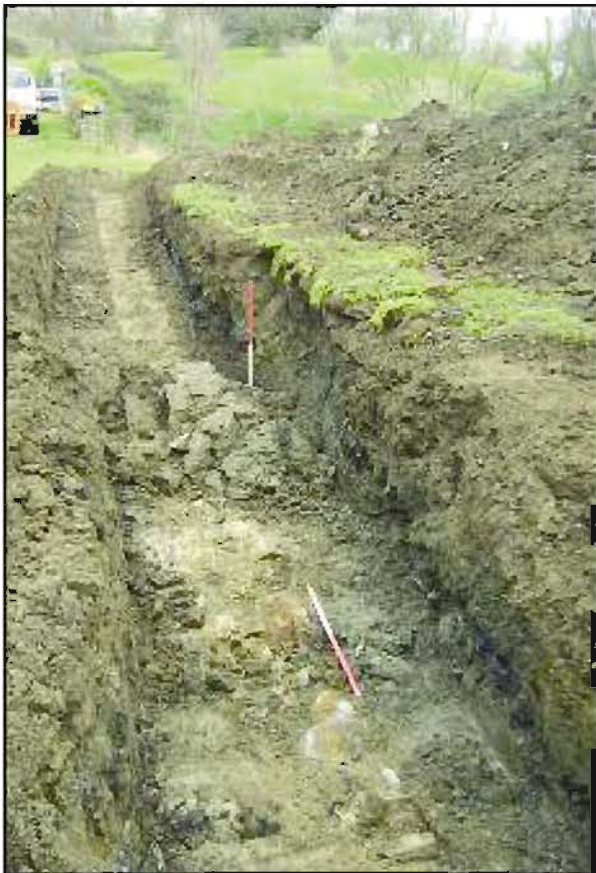
**Test Trench 1:** Wall (015) was identified within Test Trench 1, approximately 0.95 m below the current ground level; it traversed the entire 30 m length of the test trench. Only one course of the wall remains survived *in situ*, measuring 0.58 m in width by 0.15 m in height. Beneath these remains approximately 8 courses of the foundation footing was noted. This measured 1.20 m in height; however, the base was beyond the limits of the 7 tonne mini-digger. It was therefore not possible to ascertain the depth to which the foundation material was set; although local residents estimate that the eastern wall of the structure linking Balheary Bridge and Lissenhall Bridge was over 20ft in height (*pers.comm.*). The foundation footing was extremely well built, constructed from quarried limestone blocks bonded with lime mortar, and was neatly faced on the eastern side. The wall remains consisted of two rows of large quarried limestone blocks that were bonded with lime mortar. Between these rows was a rubble infill core which had also been bonded with lime mortar (Figure 3; Plates 10-13). A wall cut (014), measuring 0.40 m in width, was visible on the western side of the wall. Post-medieval pottery (white ware) and some rusty pieces of metal were noted within the fill of this cut indicating an 18<sup>th</sup>/19<sup>th</sup> century date. Wall (015) was positioned exactly 9.60 m from the existing *in situ* western wall. This is the same distance noted between the existing walls of Lissenhall Bridge suggesting that it may be part of the same construction. Wall (015) continued beyond the southern limits of Test Trench 1 and may have continued south to Balheary Bridge. A substantial layer of dumped and backfilled tar-macadam slabs were identified in this location. This may have hampered the results of the ground penetrating radar survey, which depicted wall (015) stopping after 30 m.

The archaeological assessment carried out in Testing Area 6 confirmed the existence of a wall (015) extending 25 m from the southern end of the eastern wall of Lissenhall Bridge. This wall was also identified in Test Trench 3 located approximately 10 m south of Test Trench 1 and confirms that an eastern wall once bordered a structure which spanned from Balheary Bridge to Lissenhall Bridge. The dating of wall (015) is somewhat uncertain but it appears to be of post-medieval date and possibly represents a rebuild of an earlier medieval structure. The foundational material of wall (015) was not encountered and it is possible that wall (015) was constructed over medieval foundations.

Plate 10 - Wall (015) within Test Trench 1, Sub-area 35, on same alignment as existing eastern wall of Lissenhall Bridge, facing north.

As noted, the archaeology identified in the testing area was located in Test Trenches 1-3, Sub-area 35 (Balheary Demesne 1). It is recommended that if possible the sub-surface bridge remains should be preserved *in situ*. Where an impact from the development is deemed unavoidable a programme of preservation by record should be undertaken. This would include the removal of overburden from the entire area subject to an impact so that the full extents of the bridge remains can be exposed and the deep lying base of the structures can be located in a safe fashion. A full architectural survey should then be undertaken and if necessary the structures should be dismantled under archaeological supervision.

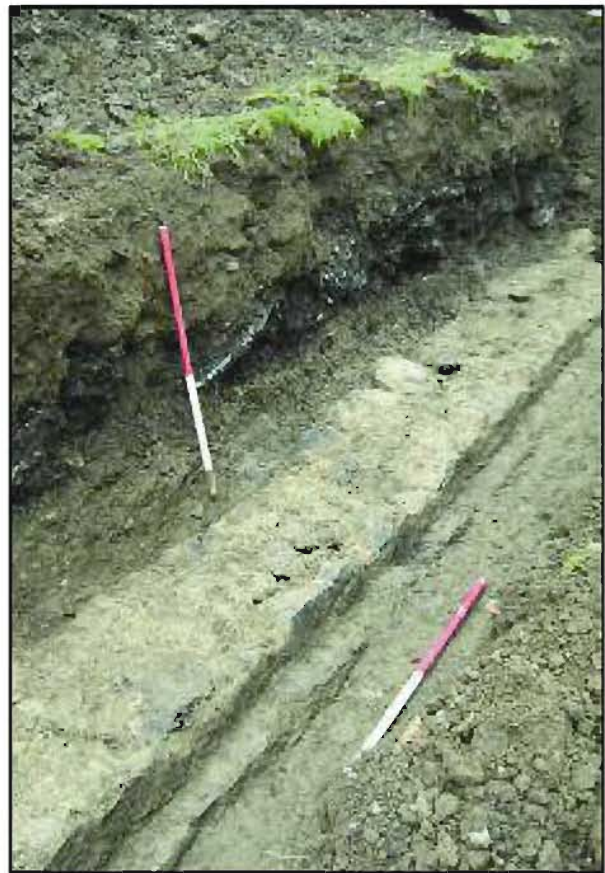
Plate 11 - Modern road surface debris over wall (015) within Test Trench 1, Sub-area 35, facing southeast.

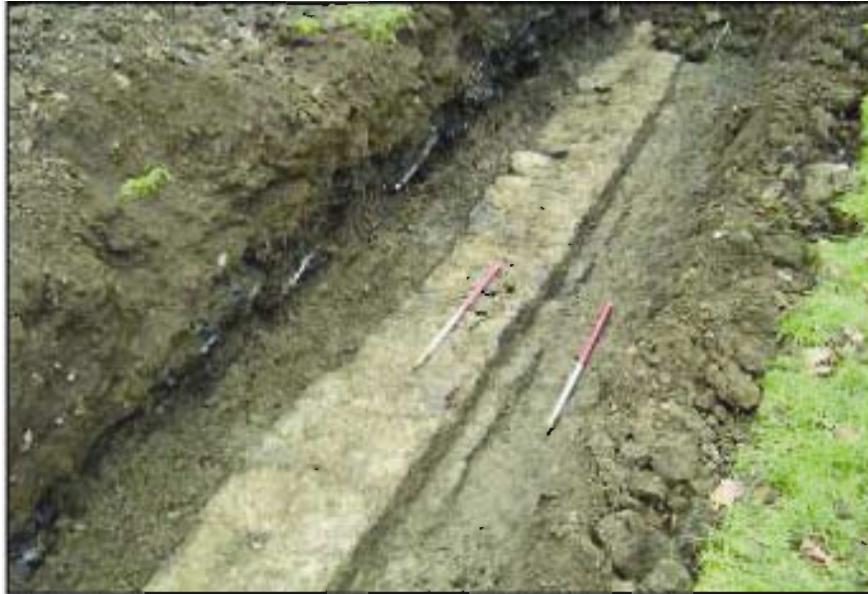
Plate 12 - Photograph of upper coursing of wall (015) within Test Trench 1, Sub-area 35, facing southeast.

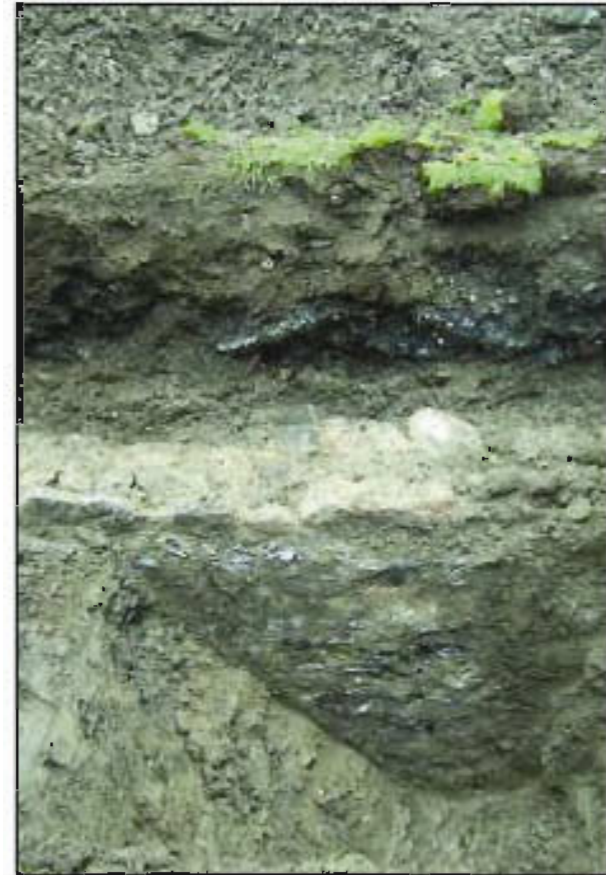
Plate 13 - Photograph of lower coursing of wall (015) within Test Trench 1, Sub-area 35, facing east.

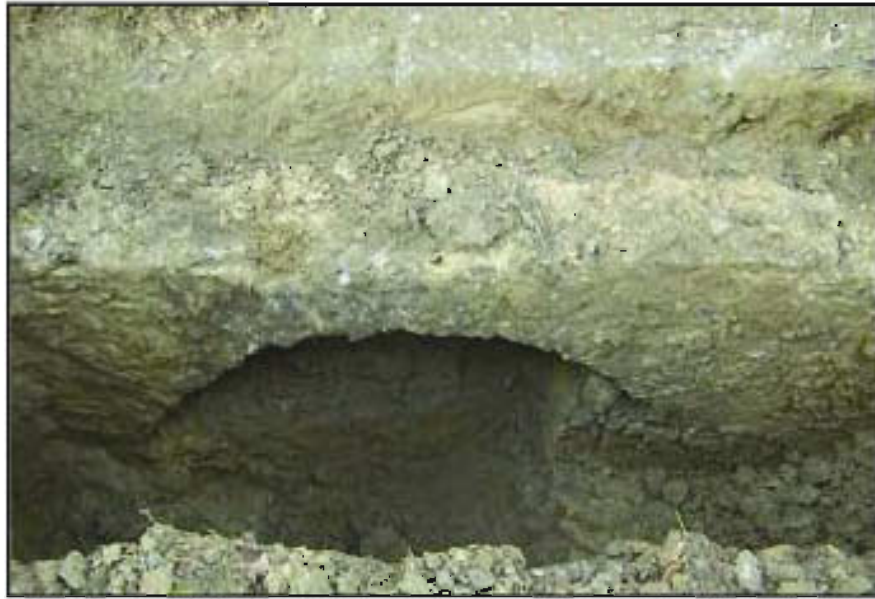
Plate 14 - Photograph of arch/culvert (016) within Test Trench 2, Sub-area 35, facing west.

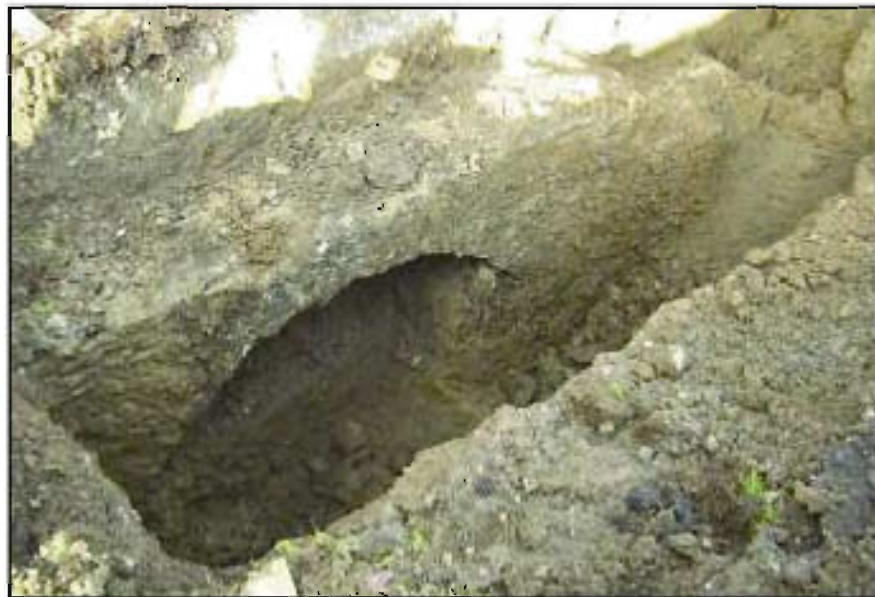
Plate 15 - Photograph of arch/culvert (016) within Test Trench 2, Sub-area 35, facing northwest

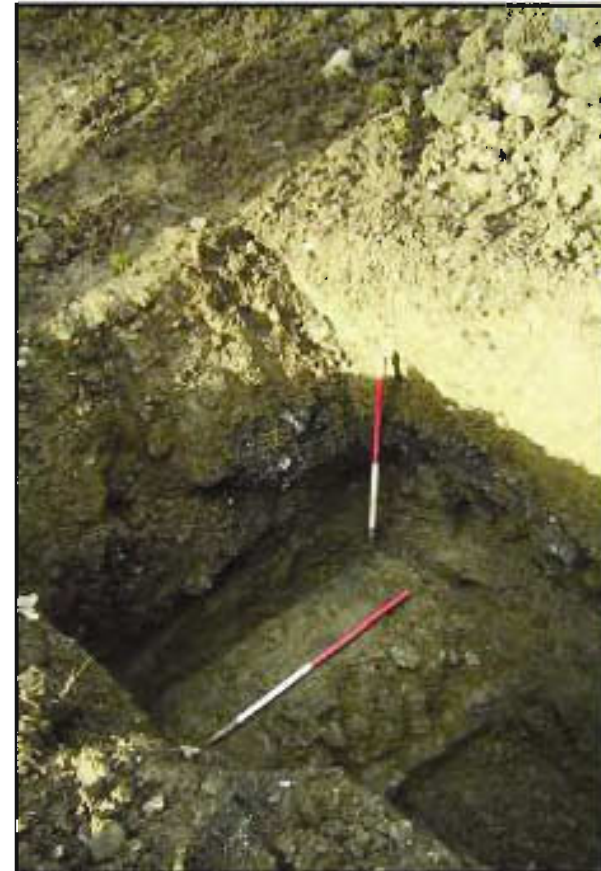
Plate 16 - Photograph of wall (015) within Test Trench 3, Sub-area 35, facing northwest.
