## Appropriate Assessment Screening – Note TO270/RM02

Project:	5162555_TO 270 Munster Bridges		
Subject:	Reactive Maintenance - AA Screening No. 2		
Author:	Paul O'Donoghue, Atkins Principal Ecologist	Atkins No.:	Appropriate Assessment Screening – Note TO270/ RM02. Revision 1.0
Date of Query:	30/10/2018	Date Issued:	5/11/2018
Distribution:

Bridge	<b>Kilmurry Bridge</b>
Structure ID	CL-N67-015.00
County	Clare
Location	On the N67, approximately 1km south of Quilty, Co. Clare (ITM ref: 502140.997, 673733.9987).

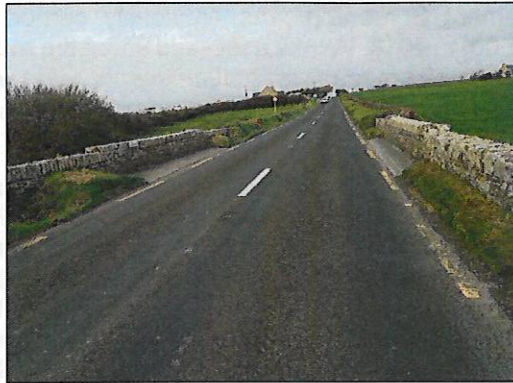
**Plate 1.** Kilmurry Bridge. View from deck [Source: Atkins R.E.; 26/10/2018].

The location of the Qualifying Interests<sup>8</sup> relative to the works is detailed below. Kilmurry Bridge is located on the N67 surrounded by agricultural grassland (see e.g. Map 1; Plate 1 & 2). Within the SPA Barnacle geese occur on Mutton Island, an island just over 1km offshore. There will be no direct or indirect impacts to Barnacle Geese using the island from the proposed works. Barnacle Geese are not known to feed at the works area.

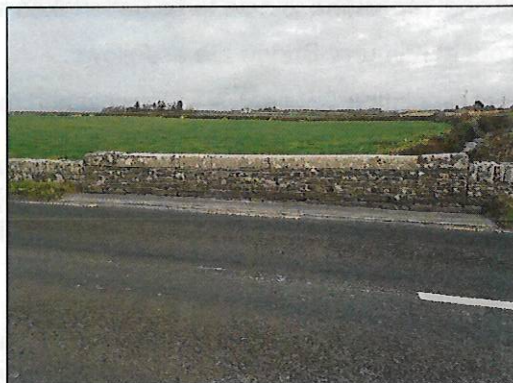
**Plate 2.** Kilmurry Bridge and stream [Source: Atkins R.E.; 26/10/2018].

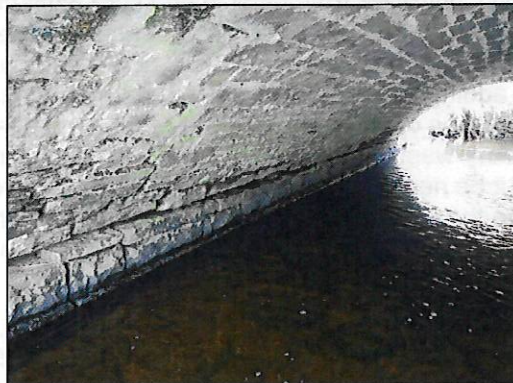
**Plate 3.** Stonework requiring repointing at base of arch [Source: Atkins R.E.; 26/10/2018].

A Principal Inspection undertaken in 2017 noted the opening along the base of the arch and described it as an open joint to be repointed (Plate 3); however following a recent site visit the condition of the bridge was re-assessed. The mortar has been fully washed out resulting in settlement of the masonry. The affected areas need to be repaired and grouted (backfilled) to prevent further masonry being washed away and the arch barrel settling and cracking. The arch barrel in its present condition is fine apart from areas of mortar loss on both sides above the springing point (i.e. the level where an arch or vault rises from a support). Some additional repointing is also to be undertaken as noted below.

- 15m<sup>2</sup> of parapet repointing (mix between internal and external faces; with the latter over water);
- 15m<sup>2</sup> repointing to wing/spandrel walls (including over water – ca. 3-4m<sup>2</sup>);
- 17m<sup>2</sup> repointing to the abutments (full area of each wall);
- 10m<sup>2</sup> repointing of arch barrel (mainly above abutment springing); and
- Grouting of backfill behind the south abutment.

Instream works will be required. The riverbed in front of both abutments would need to be dried out to facilitate repointing. This would be done by creating a line of sealed sandbags in order to create a dry works area along the base of the bridge arch. The repointing will most likely be by hand given the small area; though the appointed Contractor may elect to pressure point the abutments<sup>1</sup>. No pre-washing by e.g. power hosing is required. The mortar to be used will be NHL 5. NHL 5 is a natural lime mortar with no artificial additives or plasticisers. Mixing the mortar involves adding water and mixing in a drum or by hand to the correct consistency. This would be done on the bridge deck with prepared mortar brought to the works area. Any waste material will be collected and removed from the works area. Should it be necessary clean pea gravel will be laid within the works area to fully reinstate the river bed following completion of works. Sandbags will then be removed allowing water to re-enter. Duration of works is likely to be 2-4 days.
