Project code: MSBD11
Client: BAM Contractors Ltd. on behalf of Railway Procurement Agency
Date: October 2012

Final Report on archaeological investigations at the Metro North Mater Stop Box (MN106), Mater Misericordiae Hospital, Dublin 7

Director: James Hession
Report Author: Lyndsey Clark and James Hession
Licence No: 11E0458
Planning Reference: An Bord Pleanála NA0003
Report Status: Final

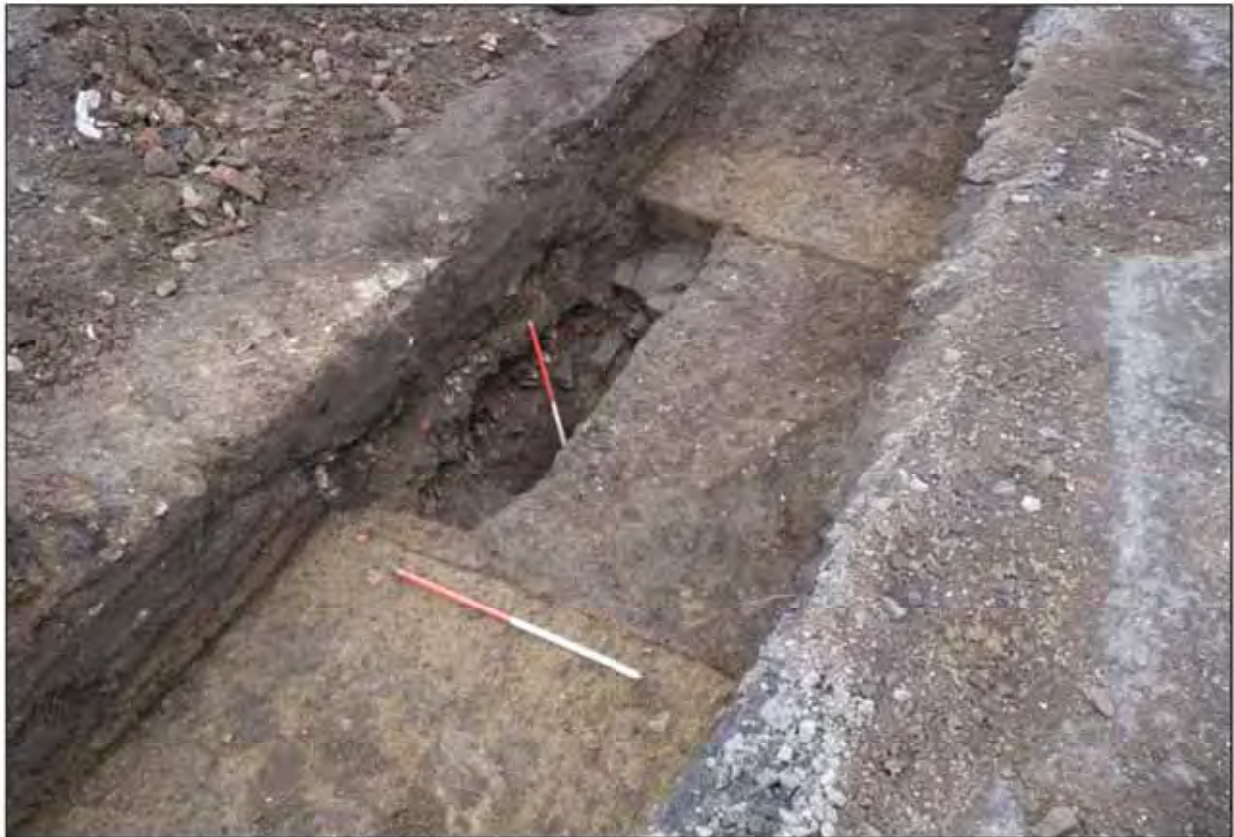
Plate 4. Culvert (005) within Test Trench 1 facing southeast.

Orientated east–west culvert (005) measured approximately 2m in width. An exploratory hand dug section into the culvert identified a stone wall along the northern edge of the cut and a timber plank (006) along the centre of the culvert, which was believed to represent the surface of a timber plank built conduit. The plank/possible conduit (006) was overlain by two distinct fills; a moist grey silty clay, which lay under a dark grey brown sandy clay that was dominated by inclusions of red brick rubble and large-sized stones. Frequent amounts of animal bone, glass and 18th/19th century ceramics were identified within this material (Plate 4).

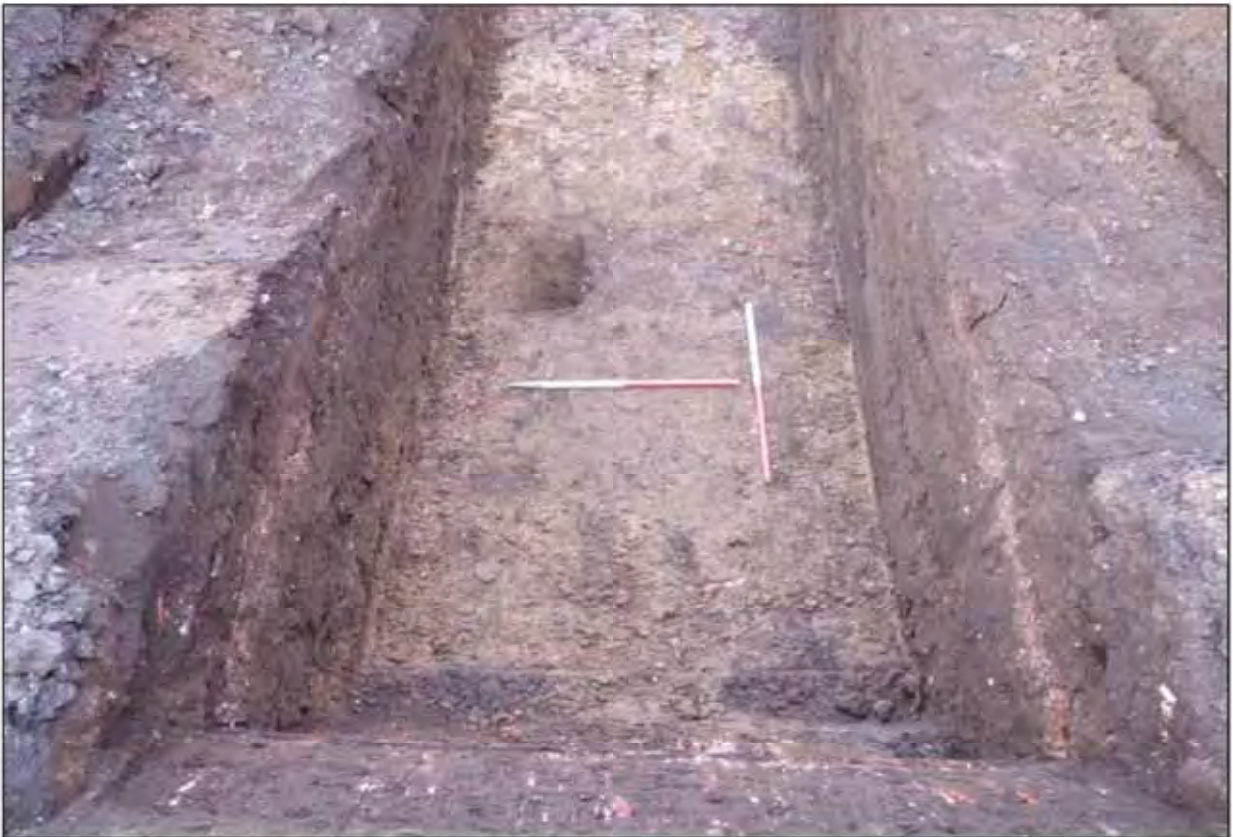
Plate 12. Culvert (005) within Test Trench 6.

by a substantial layer of re-deposited natural. This material was truncated along its northern extent by a linear feature—later identified as a robber trench (008) (Plate 12). Frequent amounts of animal bone, glass and 18th/19th century ceramics were noted within the upper fill of the linear feature and on the surface of the layer of re-deposited natural.
