Appendix 7 – An analysis of the wood excavated from Metro North Stop Box, Mater Misericordiae Hospital, Dublin 7 (11e0458)

INTRODUCTION

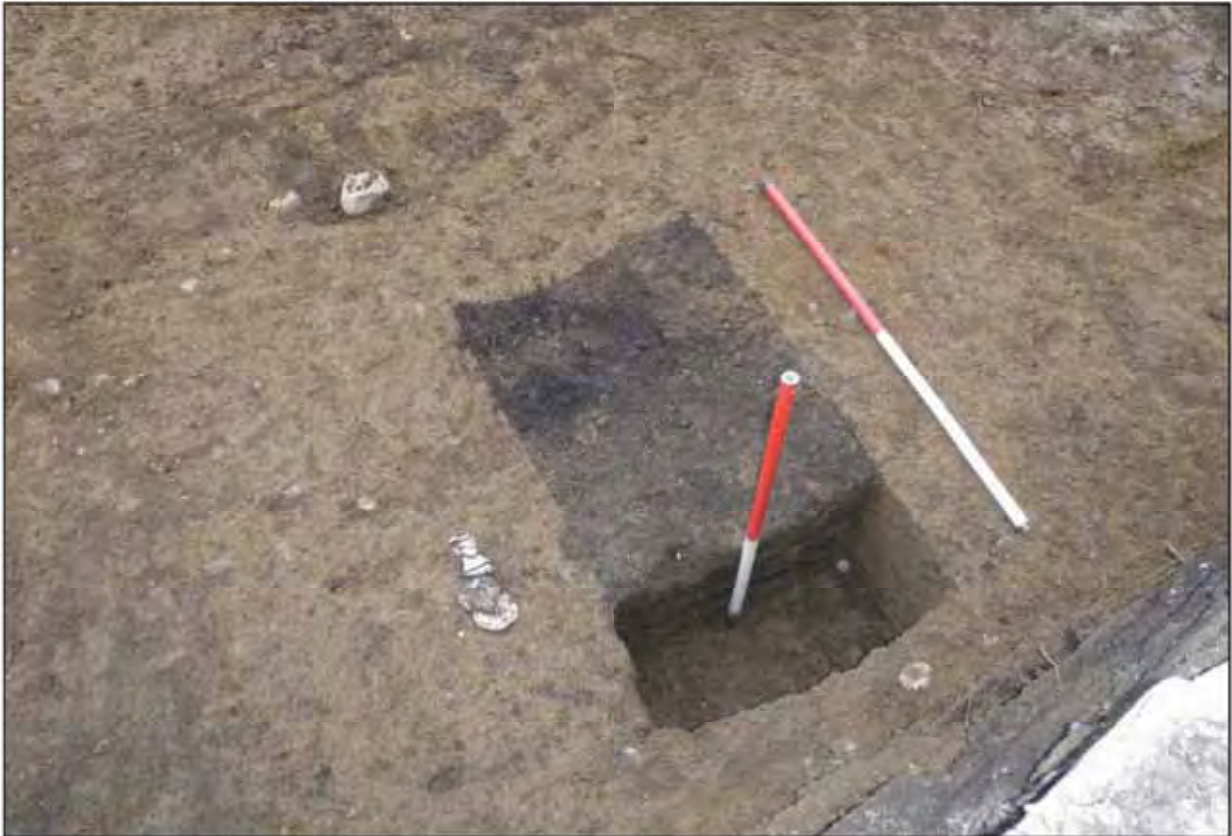
Plate 25. Geotechnical test pit (012) identified during monitoring programme facing south-east .

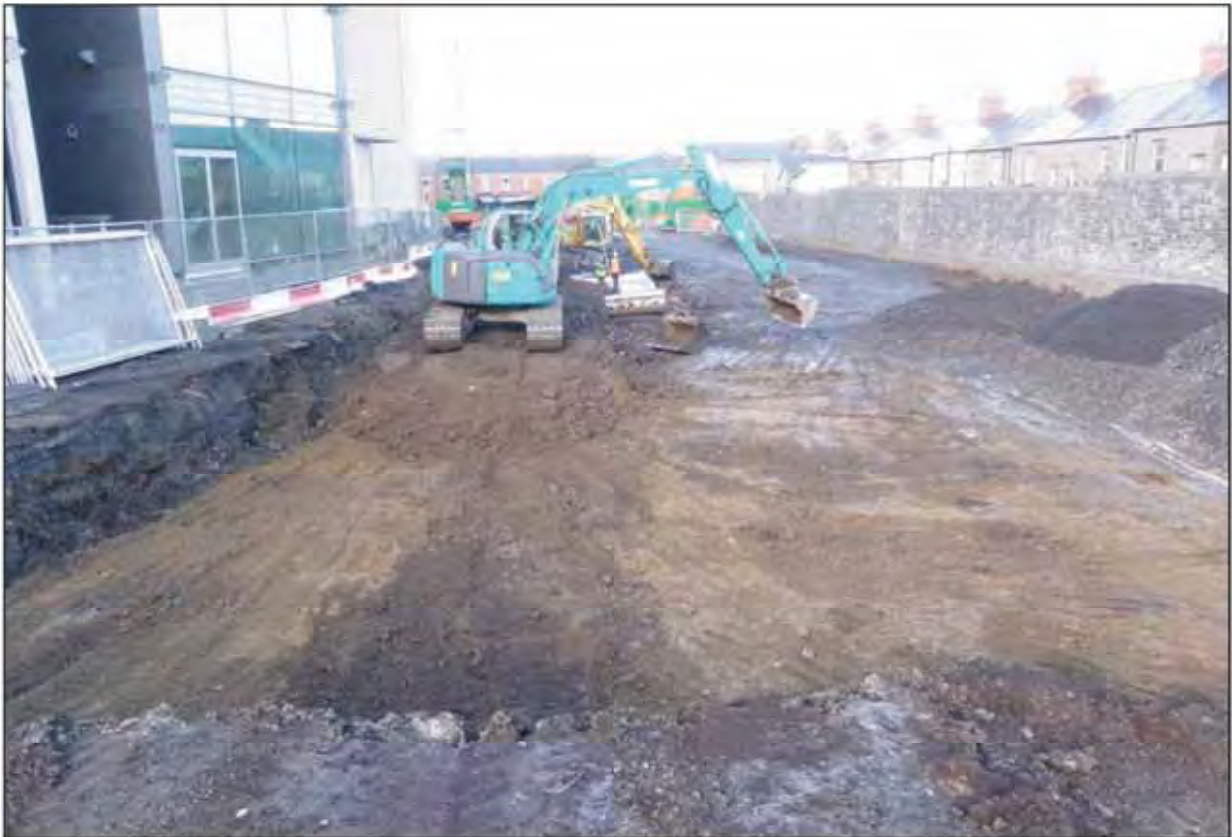
Plate 26. Outline of sewerage main evident along western side of the site facing north.

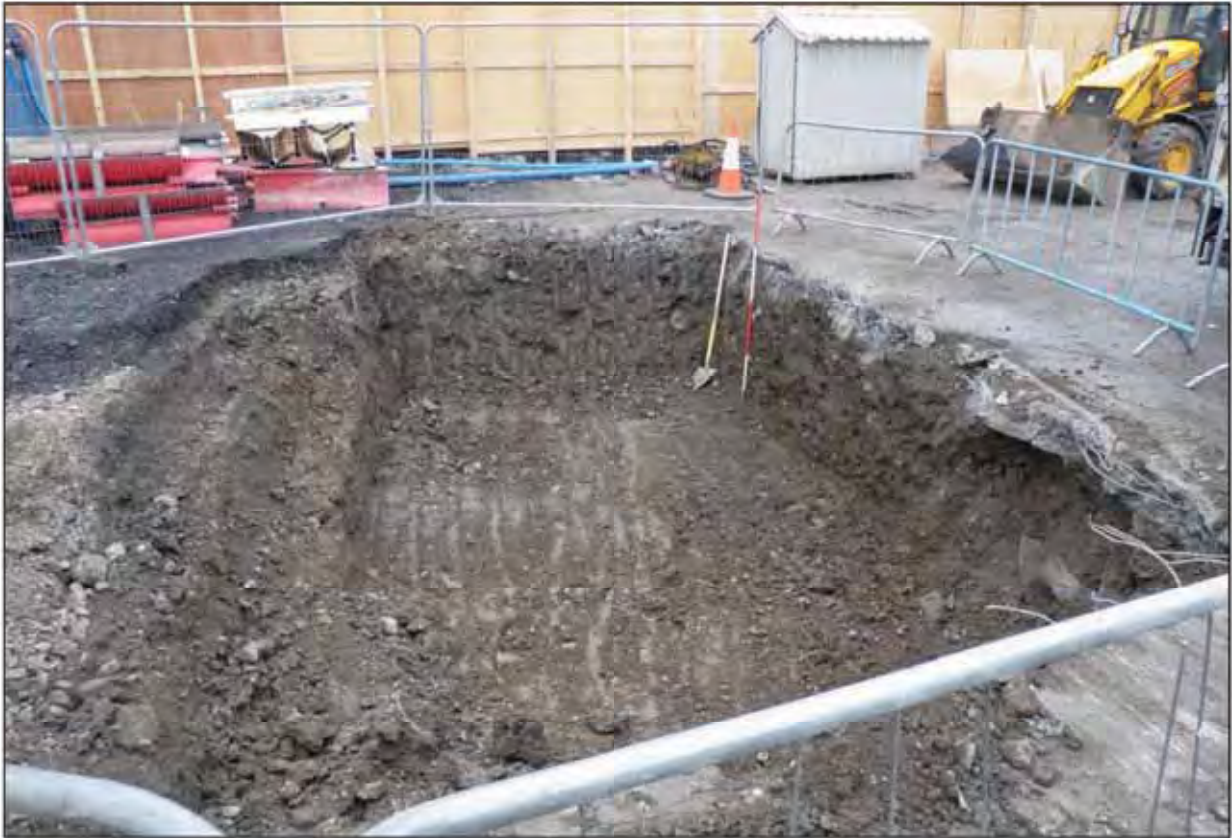
Plate 27. Mater D-wall test panel excavation facing west.

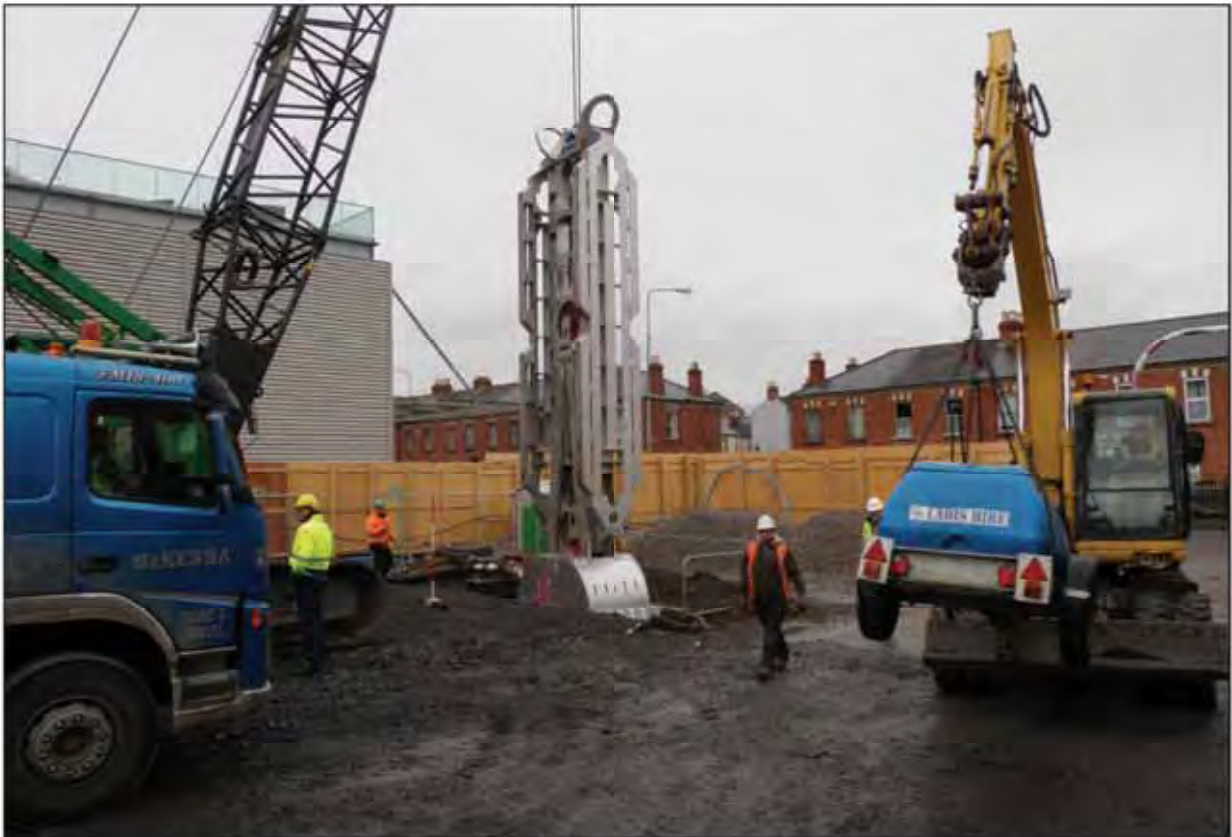
Plate 28. Hydromill excavating Mater D-Wall test panel facing north-west.

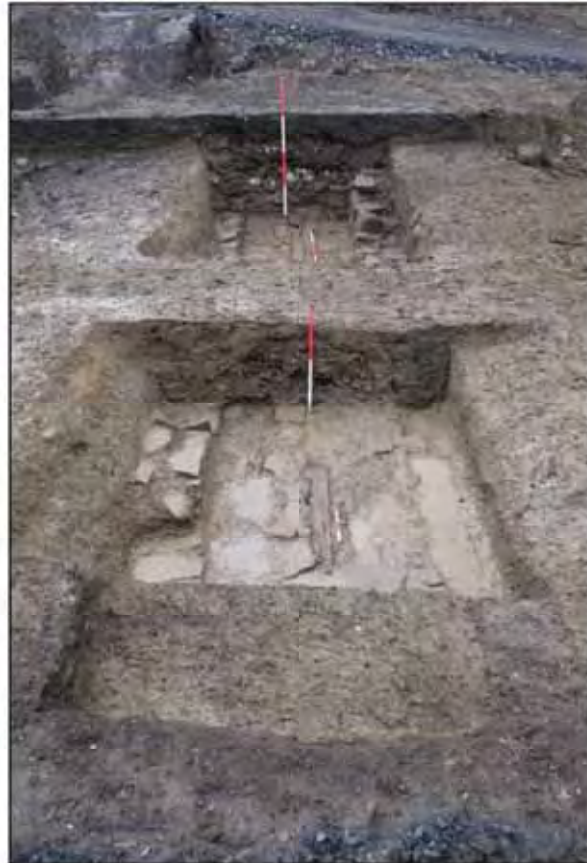
Plate 29. Mid-excitation shot of culvert (005), walls (026), (027) and stone lined drain (028) facing west.

The results of the excavation at the Mater Stop Box site identified a post-medieval culvert (005) that most likely functioned in water management or the removal of water from the area. The culvert was constructed from of a stone wall along the northern edge of the cut and a timber plank (006) along the centre, which was believed to represent the surface of a timber plank built conduit. In addition a wooden platform (033) was identified above stone-lined drain (028) within the terminus of the culvert; this may represent the floor or base of a structure (Hession 2012). A total of eight wood samples were retained from the excavation; sub-samples were obtained from all worked or possibly worked timbers identified at the site.

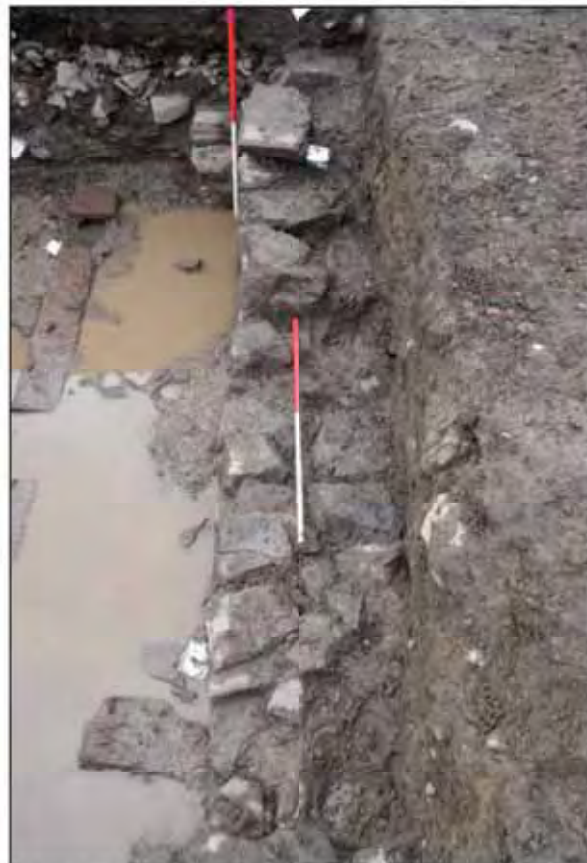
Plate 30. Northern wall (026) of culvert (005) facing west.

Context no.	Type	Fill of:	Filled by:	Length (m)	Width (m)	Depth (m)	Description	Interpretation
026	Wall	(005)	-	5.35	0.60	0.70	Linear in plan orientated east–west; it was constructed from well hewn quarried limestone blocks. It was two courses in width, three courses in height at the western extent and was constructed from large flat stones with smaller stones also noted within the configuration.	Northern wall of culvert (005)
027	Wall	(005)	-	9.80	0.50	0.40	Linear in plan orientated east–west it was constructed from well hewn quarried limestone blocks. Two courses wide, three courses in height; it was constructed from up to two rows of large-sized stones with smaller stones also noted.	Southern wall of culvert (005)
028	Stone drain	-	(032) (006)	9.80	0.23	0.18	Linear in plan with an east–west orientation. It was constructed from roughly hewn limestone boulders of differing size ranging from 0.25m by 0.13m by 0.15m to 0.37m by 0.21m by 0.11m in depth.	Stone drain along centre of culvert (005)

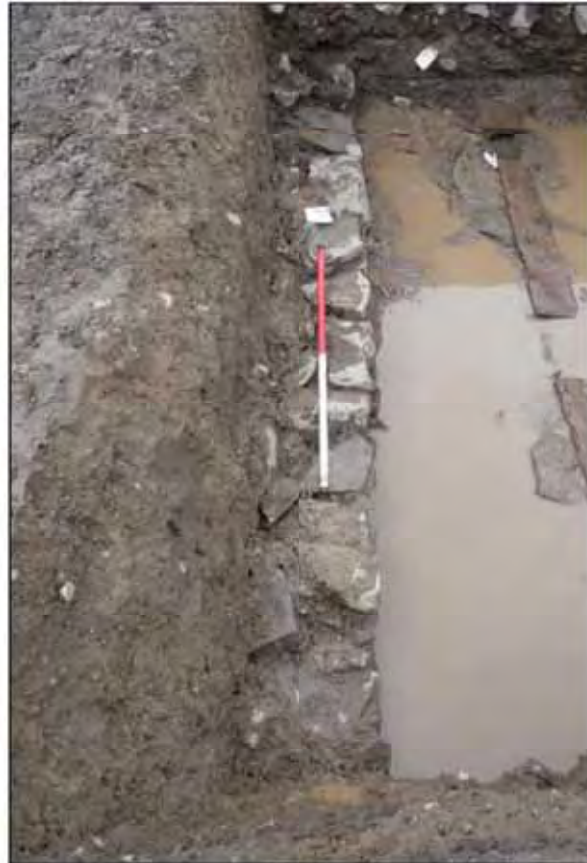
Plate 31. Southern wall (027) of culvert (005) facing west.

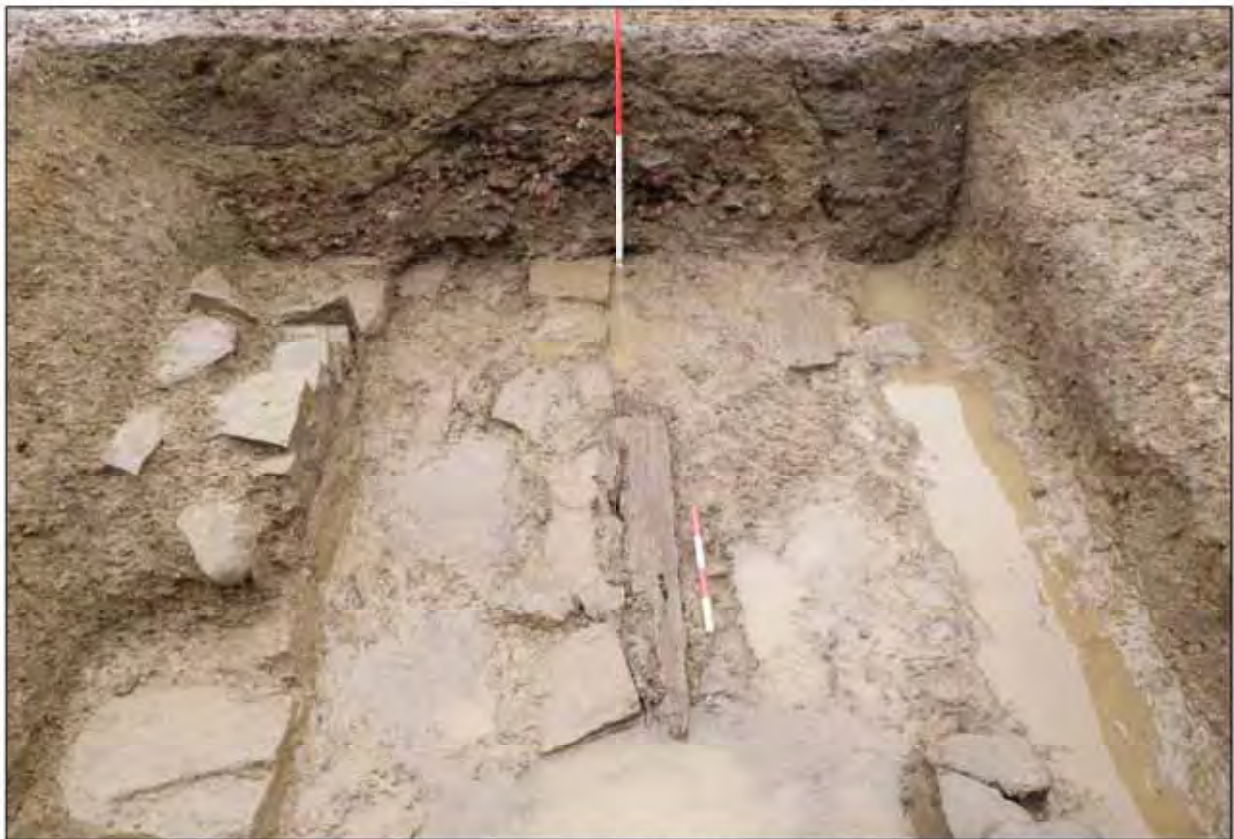
Plate 32. Stone lined drain (028) and Timber 1 (006) facing west.

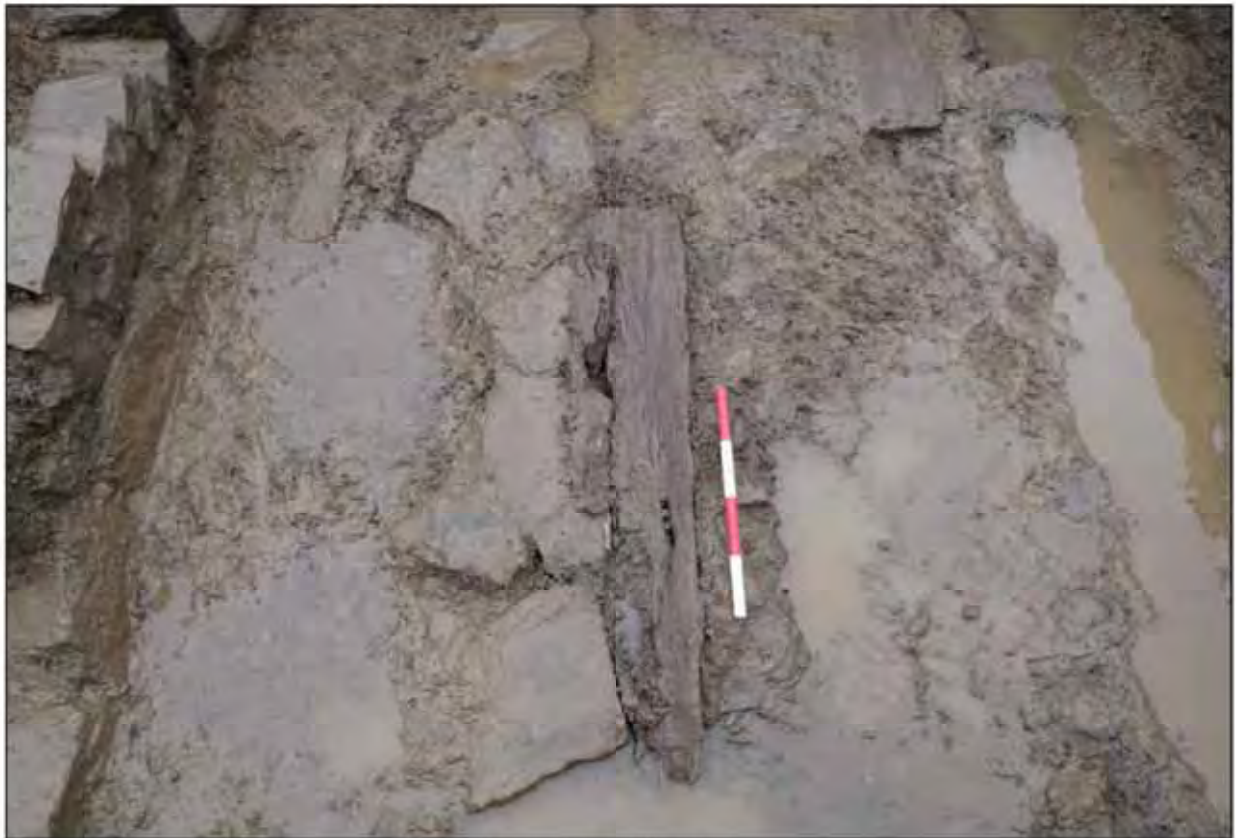
Plate 33. Timber 1 (006) facing west

Wood No.	Context No.	Description
001	(006)	Timber 1: located furthest east it measured 1.15m in length by 0.21m in width by 0.03m in depth Timber 1 was in very poor condition and only survived in a piecemeal manner. The wood itself was waterlogged and very soft. No tool marks or wood working techniques were identified on the exposed surfaces of Timber 1.
002	(006)	Timber 2: located to the west of Timber 1 the exposed section measured 0.72m in length by 0.21m in width by 0.03m in depth. Timber 2 was waterlogged, soft and generally in a poor state of preservation having split down the centre. It measured 0.72m in exposed length by 0.21m in width by 0.03m in depth. No tool marks or wood working techniques were evident.
003	(006)	Timber 3: located to the west of Timber 2 it measured 1.96m in length by 0.18m in width by 0.02m in depth. Timber 3 was also very soft and in a poor state of preservation with no tool marks or wood working techniques evident.

Wood No.	Context No.	Description	Species	Annual tree rings	Split type	Further comment	Recommendation
1	006	Timber 1: located furthest east it measured 1.15m in length by 0.21m in width by 0.03m in depth	<i>Picea abies</i>	18	Tangential	Poor condition	Dispose
2	006	Timber 2: located to the west of Timber 1 measured 0.72m in length by 0.21m in width by 0.03m in depth	<i>Picea abies</i>	20	Tangential	Poor condition	Dispose
3	006	Timber 3: located to the west of Timber 2 it measured 1.96m in length by 0.18m in width by 0.02m in depth	<i>Picea abies</i>	23	Tangential	Moderate condition	Dispose
4	006	Timber 4: located to the west of Timber 3 it measured 1.14m in length by 0.23m in width by 0.035m in depth.	<i>Picea abies</i>	18	Tangential	Poor condition	Dispose

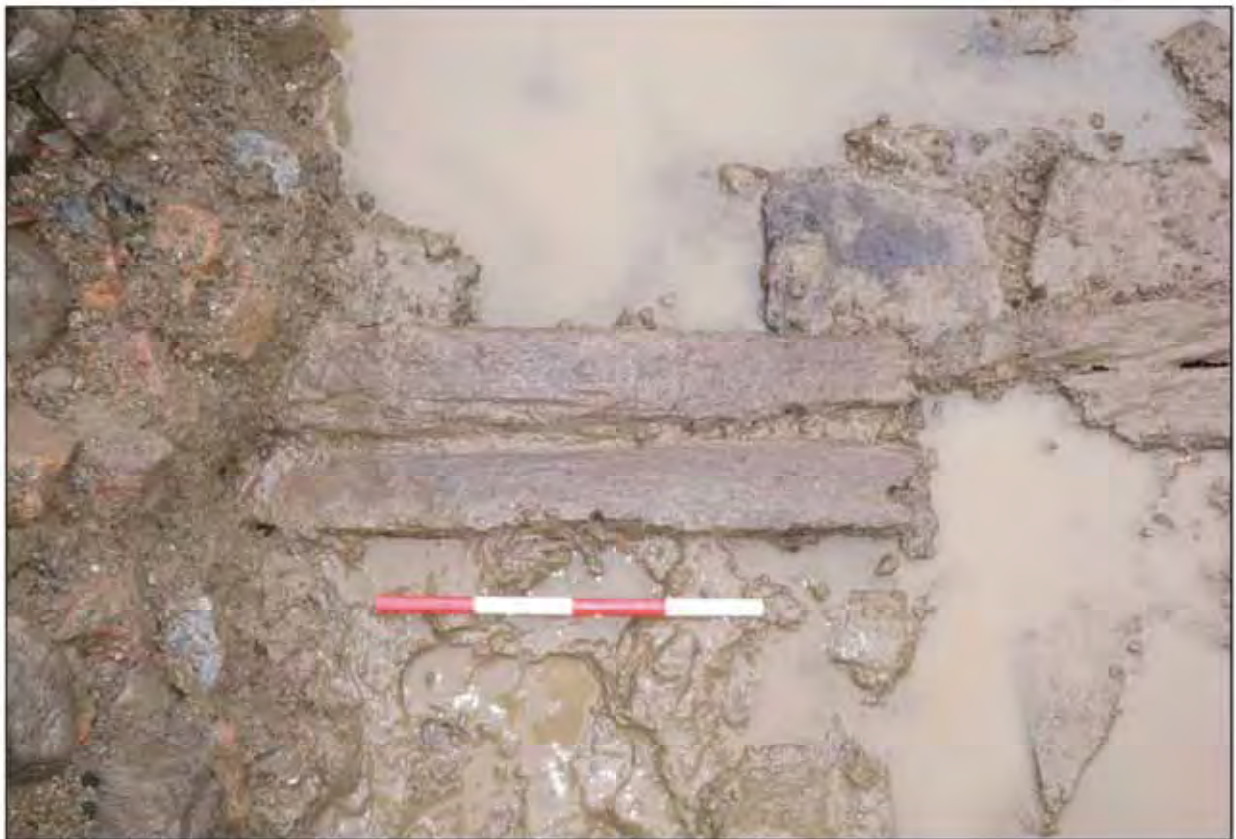
Plate 34. Timber 2 (006) facing south.

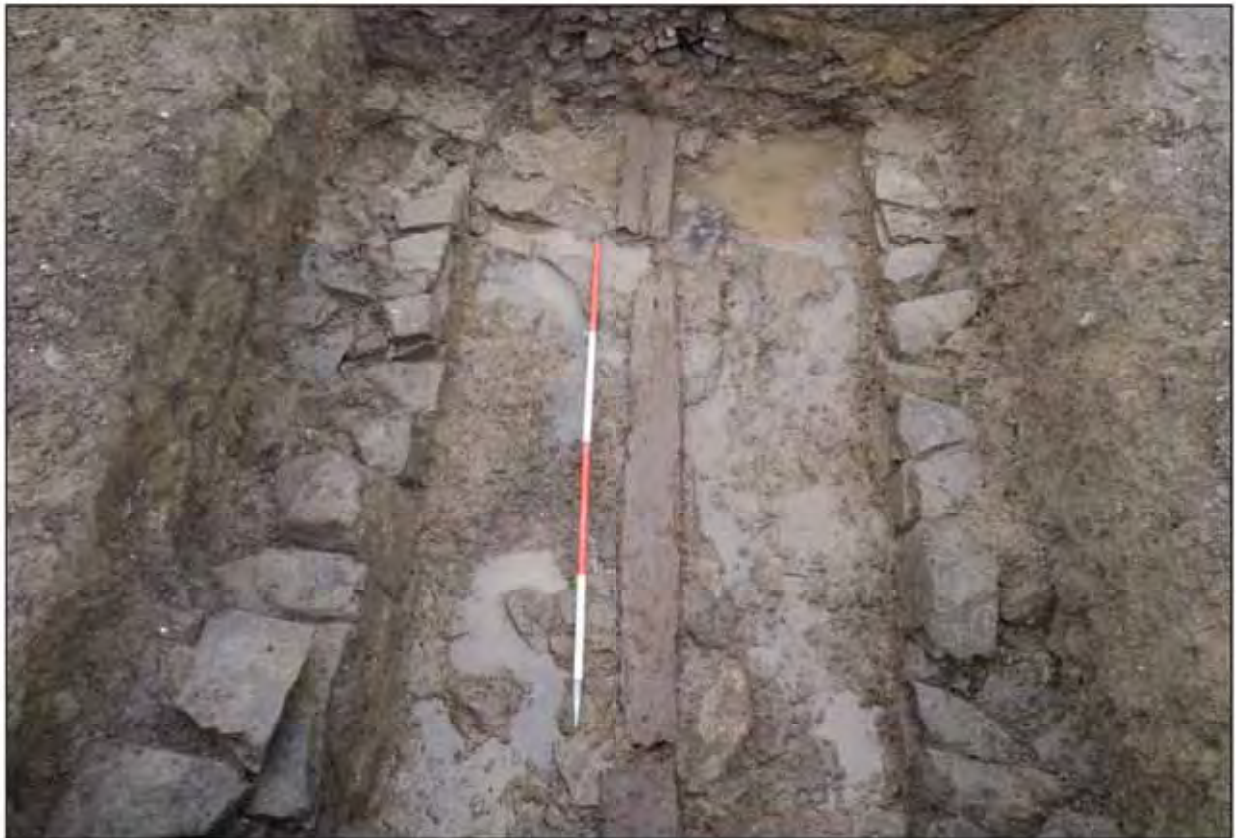
Plate 35. Timber 3 (006) facing east.

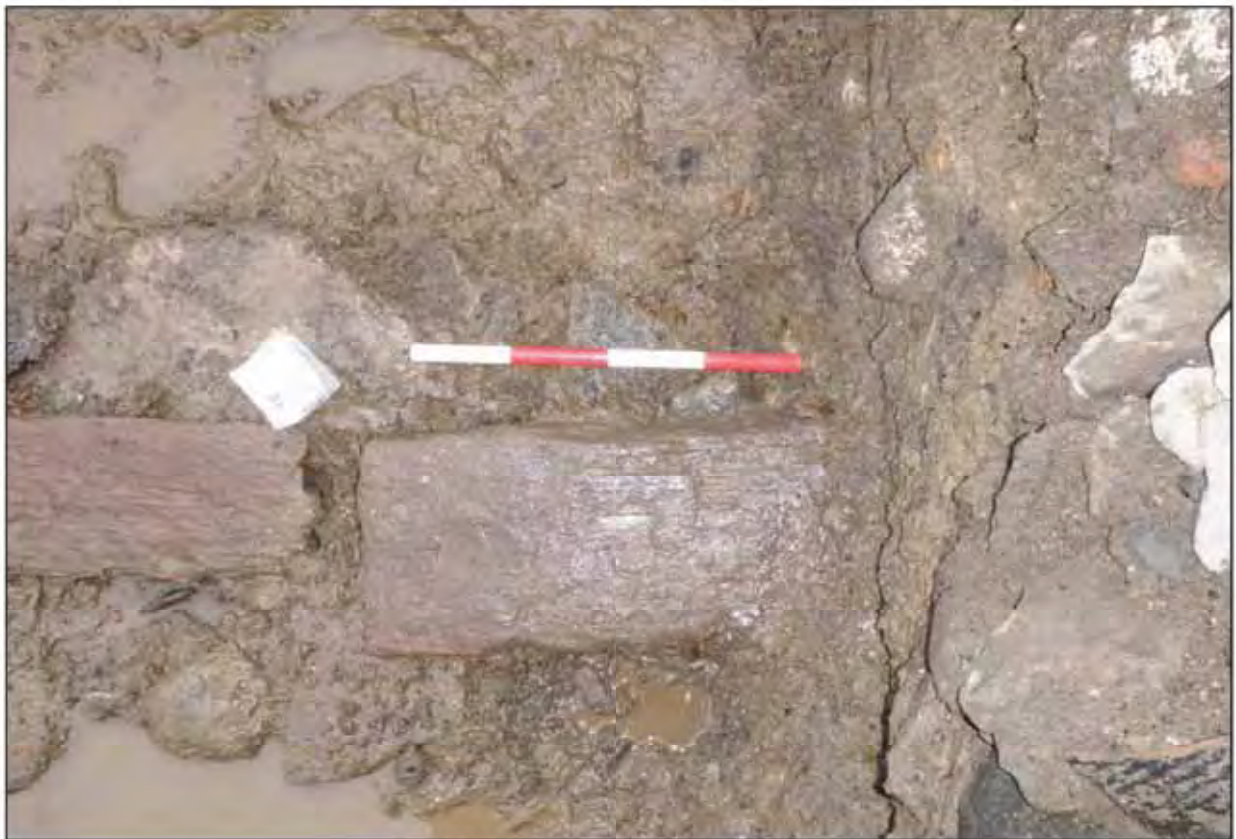
Plate 36. Timber 4 (006) facing south.

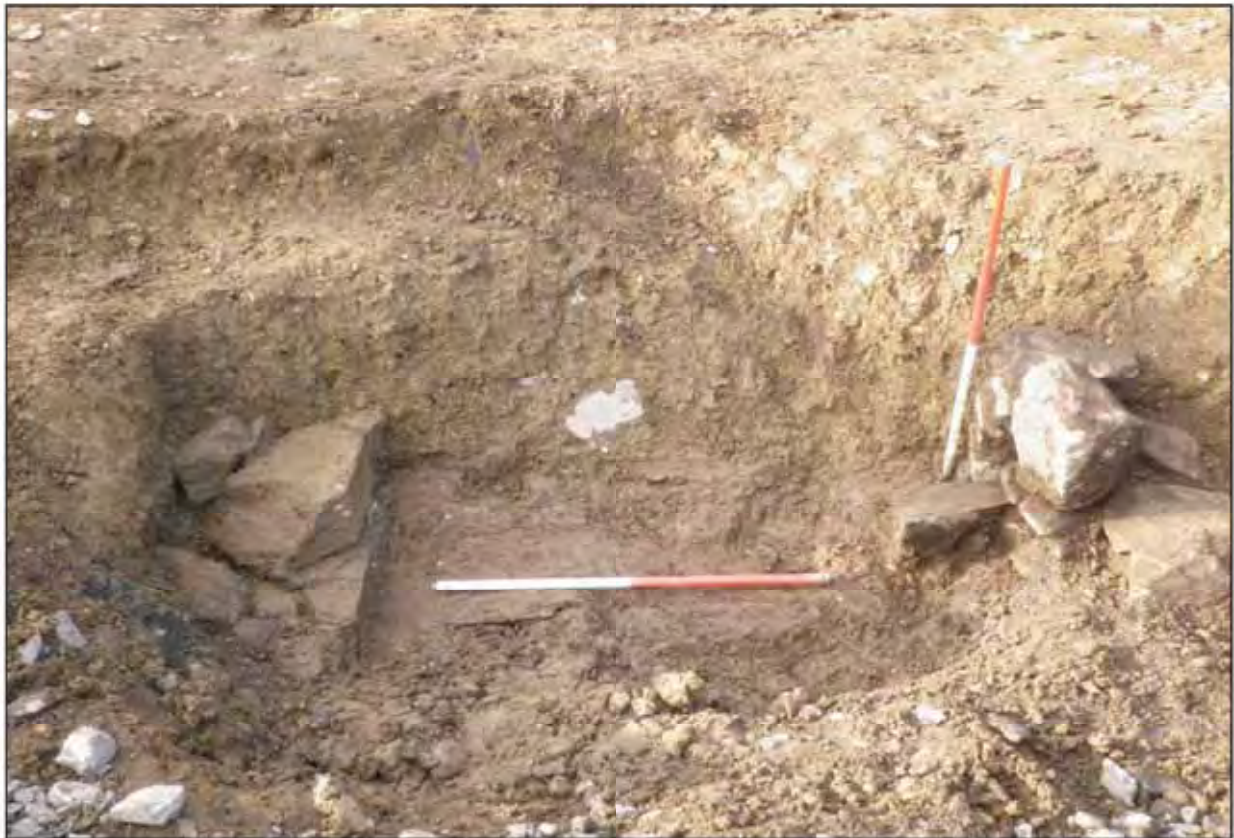
Plate 37. Timber floor (033) facing west.

Similar to the wooden culvert all timbers associated with the wooden platform structure (033) were identified as *Picea abies* or spruce wood. Three of the timbers were tangential splits and one timber was a smaller boxed inner radial split (Table 1). The growth rate was moderate and the boxed radial split contained over 45 annual tree rings suggesting a slightly older tree than the previously identified timbers. There was no tooling evidence noted on the analysed timbers.

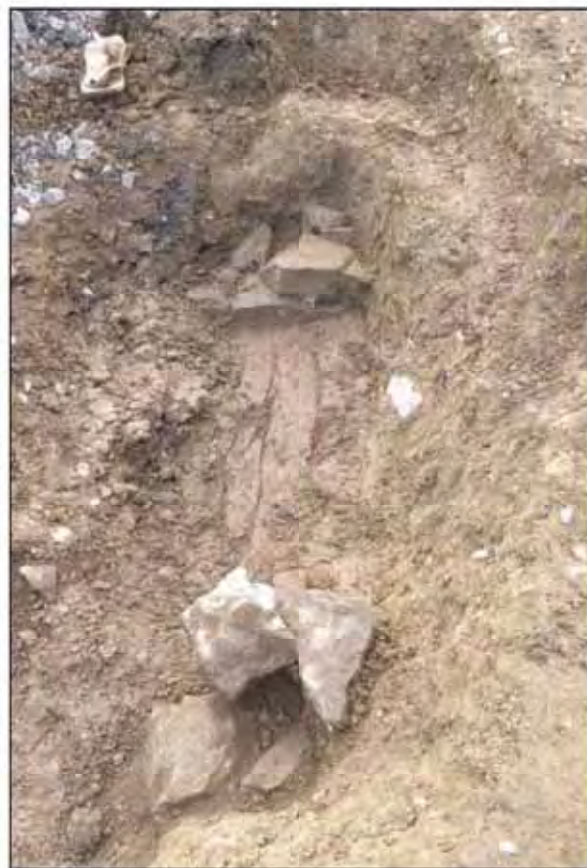
Plate 38. Timbers 5, 6 and 7 of (033) facing south.

Wood No.	Context No.	Description	Species	Annual tree rings	Split type	Further comment	Recommendation
5	033	Timber 5: identified above drain 028), it measured 1.30m in length by 0.15m in width by 0.02m in depth.	<i>Picea abies</i>	6	Tangential	Moderate condition	Dispose
6	033	Timber 6: located to the west of Timber 5 it measured 1.14m in length by 0.24m in width by 0.03m in depth.	<i>Picea abies</i>	20	Tangential	Moderate condition	Dispose
7	033	Timber 7: located to the west of Timber 5, it measured 0.50m in length by 0.24m in width by 0.05m in depth.	<i>Picea abies</i>	10	Tangential	Poor condition	Dispose
8	033	Timber 8: located on the base of drain (028) it measured 0.90m in length by 0.12m in width by 0.07m in depth.	<i>Picea abies</i>	45	Boxed inner radial	Moderate condition	Dispose

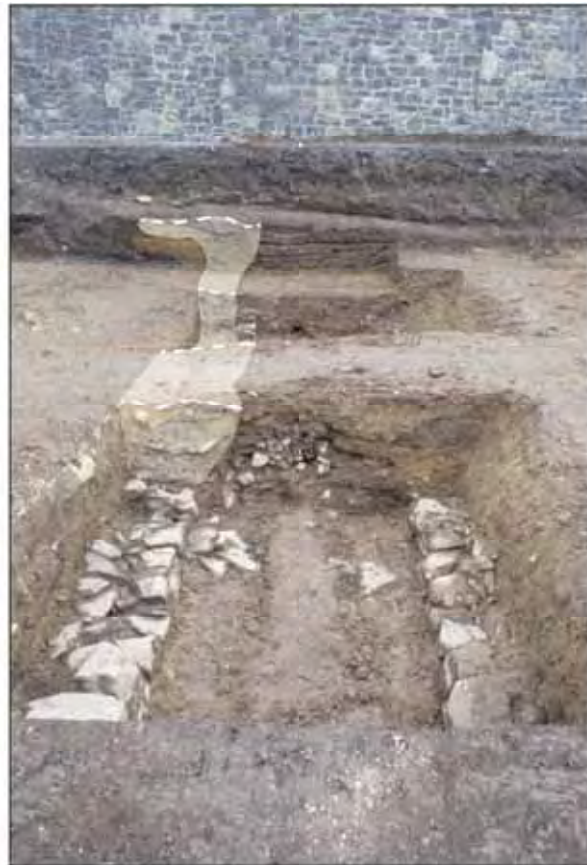
Plate 39. Robber Trench (008), highlighted, and associated fills facing east.

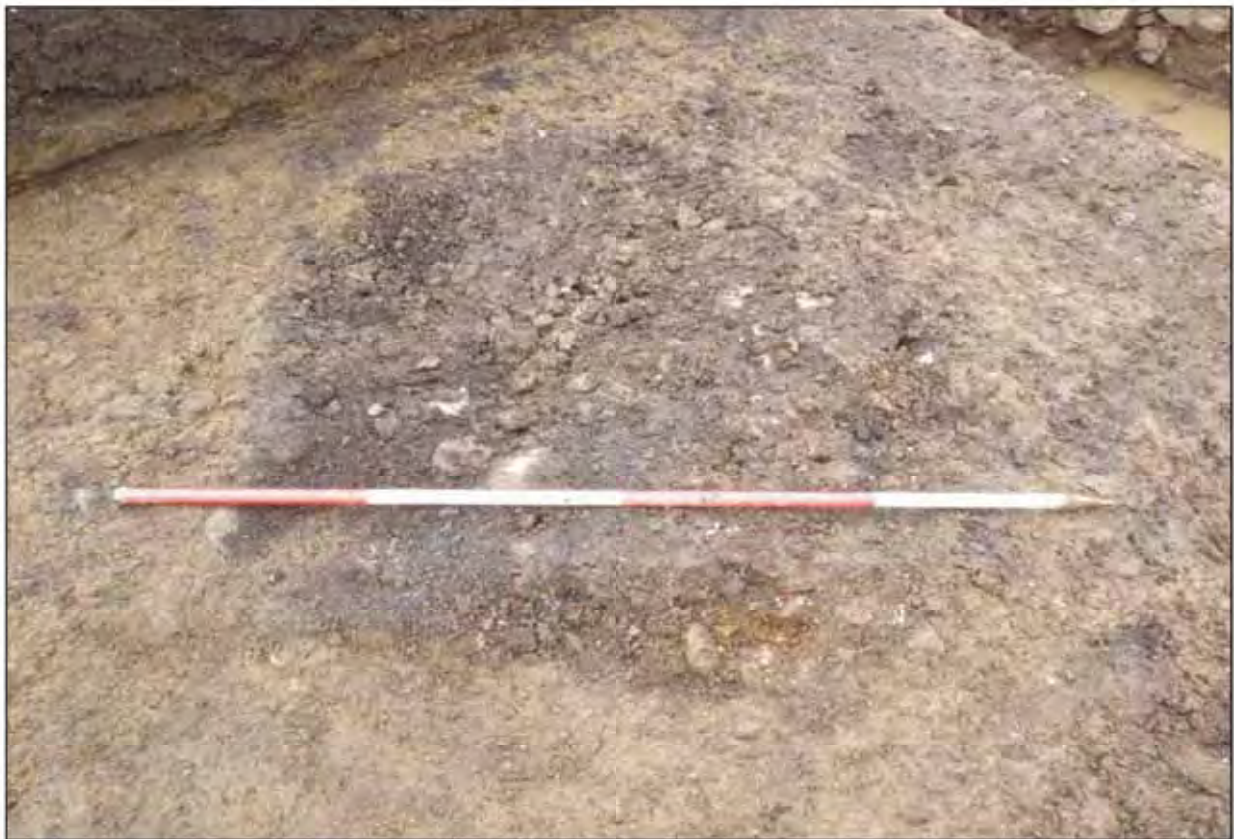
Plate 40. Mid-excavation of geotechnical test pit (010) facing north-west.

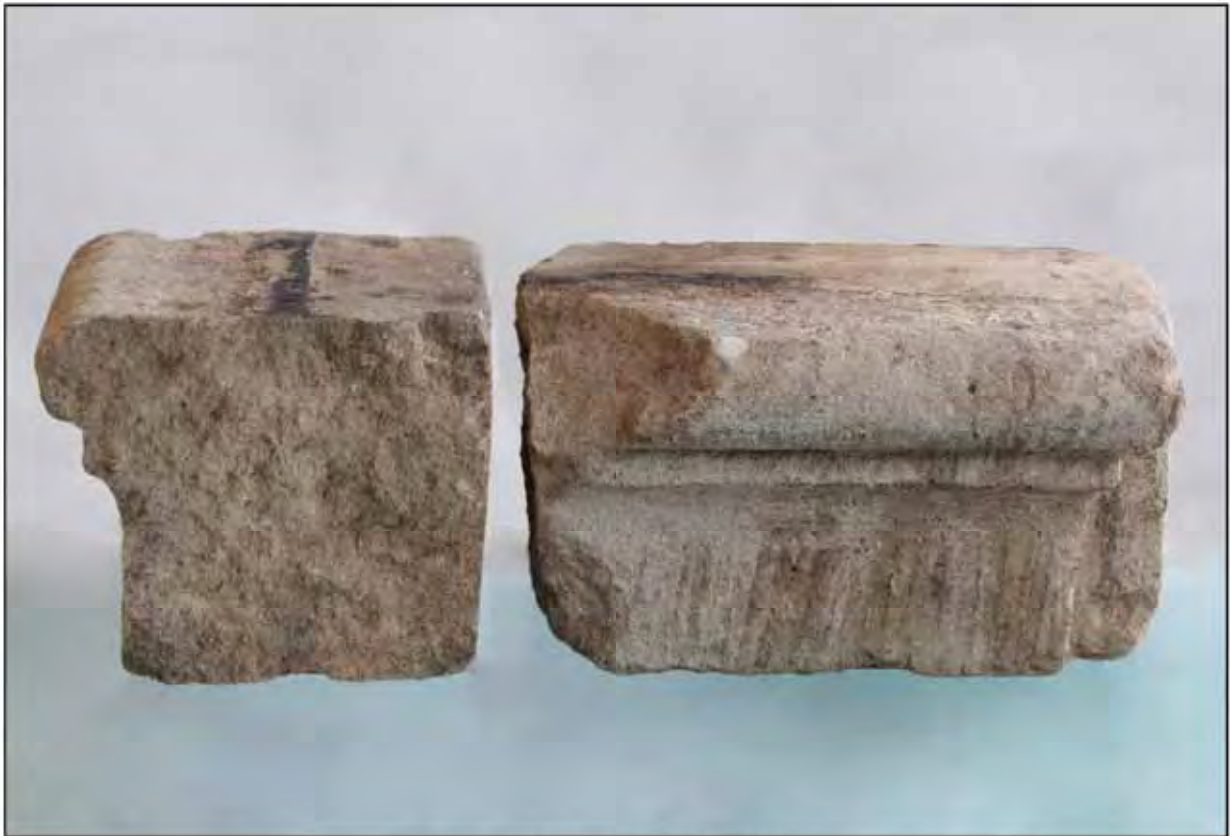
Plate 41 - Fragments of architectural stone (11E0458:009:052-053)

Two broken architectural stones (11E0458:009:052-053) were recovered during the test excavations for the Metro North Mater Stop Box (MN106), Mater Misericordiae Hospital, Dublin 7. Both fragments belong to the one piece and join together to form most likely a corner fragment of an ornate window sill.

Similar window sills were commonly used during the period between the 18th and early 20th centuries, especially in Georgian and Victorian house architecture. The excavation results support this assumption, indicating a post-1750 date for the site. The context from which both pieces were recovered is the backfill of a culvert (005). This culvert housed a stone-lined drain which most likely functioned in the removal of waste or foul water from the area. It has been noted that the Ordnance Survey 6" Map Sheet 018 (1844) depicts a small cluster of buildings which front onto the north side of Stable Lane. These buildings are in close proximity to this culvert to the west. The lane along with these buildings are not depicted on the later Ordnance Survey 25" Map Sheet 018-07 (1911). It is possible that these architectural fragments could represent demolition debris from these buildings. The surrounding architecture in the vicinity of the site is also worthy of mention due to its rich architectural heritage. The original historic stone buildings of the Mater Misericordiae Hospital (1852) are protected structures (RPS: 2437). It must also be noted that the carved granite window sills to the main façade, share a similar design to the carved stone sill fragments discussed above. While further historic architecture of other period buildings are to be found nearby to the south of the site along Eccles Street, which is considered to be one of the finest Georgian Streets on the north side of Dublin and was reputedly built between the 1750s and 1820.

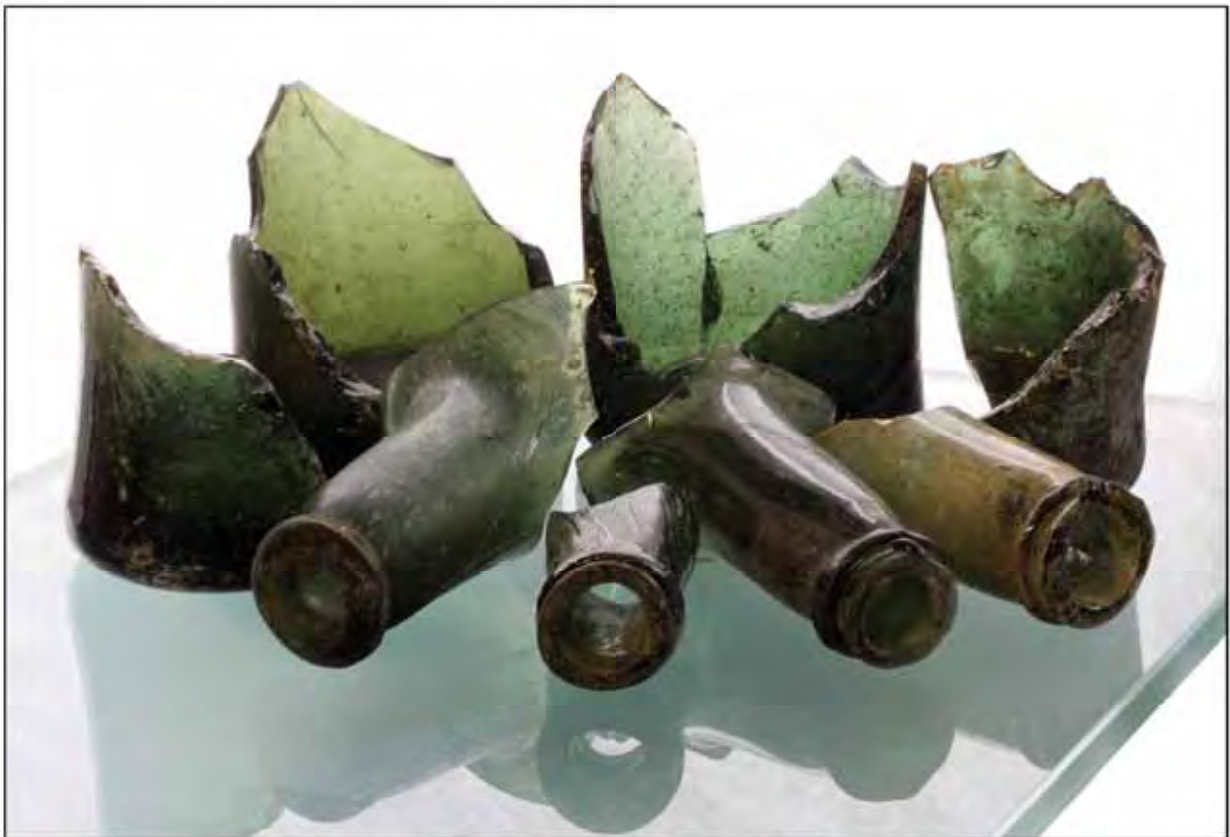
Plate 42 - Selected artefacts from the glass assemblage

Sixteen of the recovered glass fragments were bottle bases, all of them displaying disc pontil scars—a pontil scar is the mark left on the base of a bottle by the punty rod that held the bottle in place while the glass was being blown. A disc pontil scar can be recognised by rough chips of glass in a circle on the base; they are commonly found on early English and European bottles in the 18th and early 19th Century.

Thirteen of the glass fragments were represented by the neck and finish part of the bottle. The majority of these fragments were also from deposit (009). The lip of a bottle is very diagnostic. All of the lips present in the assemblage displayed an applied string rim. The string rim was a thread of glass applied around the lip of the bottle. They were used when tying a piece of thread to secure the cork or wedge of wood in place. They are commonly found on 18th century bottles (Jones 1986).

The datable glass within the assemblage lies within a time span of the early 18th-early 19th centuries. The assemblage consists of bottle glass and was dominated by wine/beer bottles, with one possible example of a domestic or pharmaceutical bottle also present. The majority of the glass was found in a deposit of dumped material (009) representing Phase II activity at the site. Dating of the glass corresponds with the date of other finds retrieved from the same deposit.

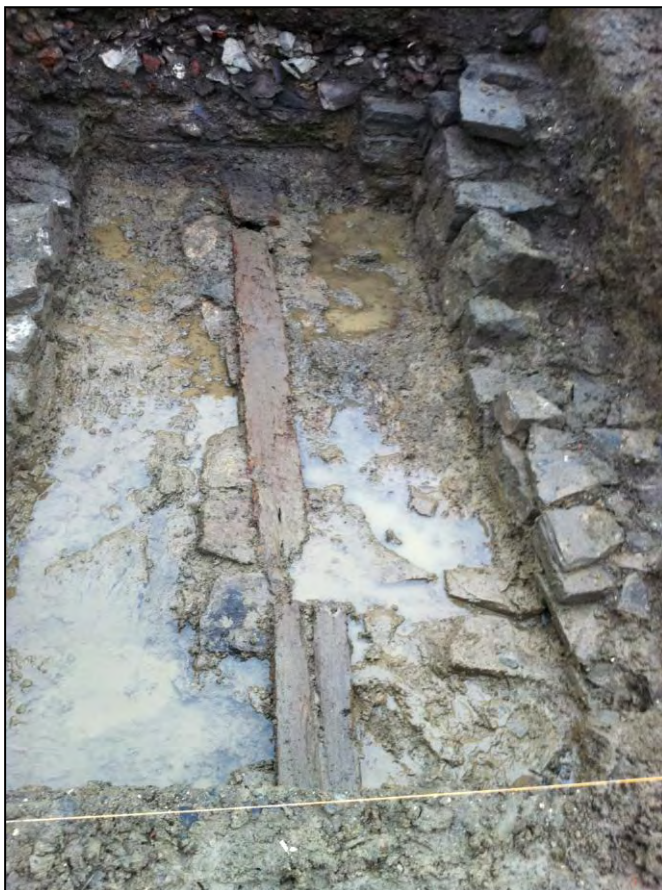
Figure 1: Wooden culvert *in situ*

All timbers identified from the wood lined culvert were of spruce wood (*Picea abies*) and were tangential splits (Table 1). The growth rate of the tree that the planks were fashioned from was moderate to slow growth. Between 6 and 23 annual tree rings were present on the sub-sampled wooden remains indicative of young trees. There was no tooling evidence noted on the analysed timbers.
